# Access Compliance Report

## Public Rights-of-Way

### (Curb Ramps)

Intersection ID: N/A	Main Street: SPRINGWOOD_ESTATE_DR	Cross Street: SAGMORE_HILL_DR	Location: SW
ADA ID: FA069986CBC4	Ramp Type: Perp	Initial Pass/Fail: Fail	Overall Compliance: No
		Severity Score: 37.5	
Codes/Mitigation Info/Possible Solution		Field Measurements/Component Compliance

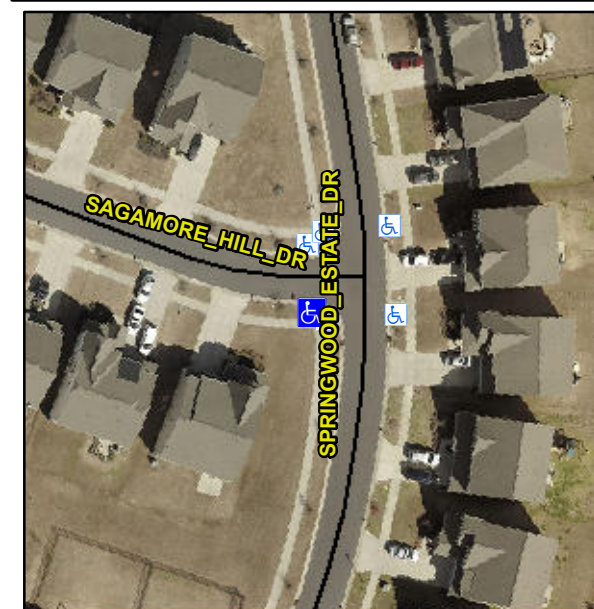
**N/A**

**Not Found, R304.2.2, R304.5.3**

Compliance	Description	Data	Compliance	Description	Data
N/A	Ramp Length (in)	98.0	No	Ramp Slope (%)	10.1
Yes	Ramp Width (in)	48.0	No	Ramp XSlope (%)	11.8
N/A	Flare Type LT	N/A	N/A	Flare Type RT	N/A
N/A	Flare Slope LT (%)	N/A	N/A	Flare Slope RT (%)	N/A
N/A	Flare Traversable LT?	N/A	N/A	Flare Traversable RT?	N/A
N/A	Landing Length (in)	N/A	N/A	DWS Provided?	N/A
N/A	Landing Width (in)	N/A	N/A	DWS Contrast?	N/A
N/A	Landing Slope (%)	N/A	N/A	DWS Length (in)	N/A
N/A	Landing X Slope (%)	N/A	N/A	DWS Full Width?	N/A
N/A	Landing Curb? (Y/N)	N/A	N/A	DWS Offset (in)	N/A
N/A	Shared Landing?	N/A			
N/A	Gutter Ponding?	N/A	N/A	Gutter Slope (%)	N/A
N/A	Gutter Lip Ht (in)	N/A	N/A	Gutter X Slope (%)	N/A
N/A	Painted X Walk1?	No	N/A	Painted X Walk2?	N/A
	X Walk 1 Direction	To N		X Walk 2 Direction	N/A
N/A	X Walk 1 Width (in)	N/A	N/A	X Walk 2 Width (in)	N/A
	X Walk 1 Slope (%)	0.0		X Walk 2 Slope (%)	N/A
	X Walk 1 X Slope (%)	7.9		X Walk 2 X Slope (%)	N/A

N/A	Ramp inside XWalk1?	N/A	N/A	Ramp inside XWalk2?	N/A
	Road Slope (%)	N/A	N/A	Clear Space?	N/A
	Road X Slope (%)	N/A	N/A	Clear Space to XWalk (in)	N/A
N/A	Any Obstructions?	N/A	N/A	Storm Grate/Utility Hazard?	N/A
	Obstruction Type			Storm Grate/Utility Type	
		N/A			N/A
			Yes	Surface Condition? (G/P)	Good

Possible Solutions:

**Remove & Replace Entire Ramp.**

Total Cost: \$ 1850.00
