# Access Compliance Report

## Public Rights-of-Way

### (Curb Ramps)

Intersection ID: 46811	Main Street: ARBOR_VISTA_DR	Cross Street: ROSE_CREEK_CT	Location:	N
ADA ID: FA07769BD1A2	Ramp Type: PerpDiag	Initial Pass/Fail: Fail	Overall Compliance: No	Severity Score: 8.75
Codes/Mitigation Info/Possible Solution		Field Measurements/Component Compliance

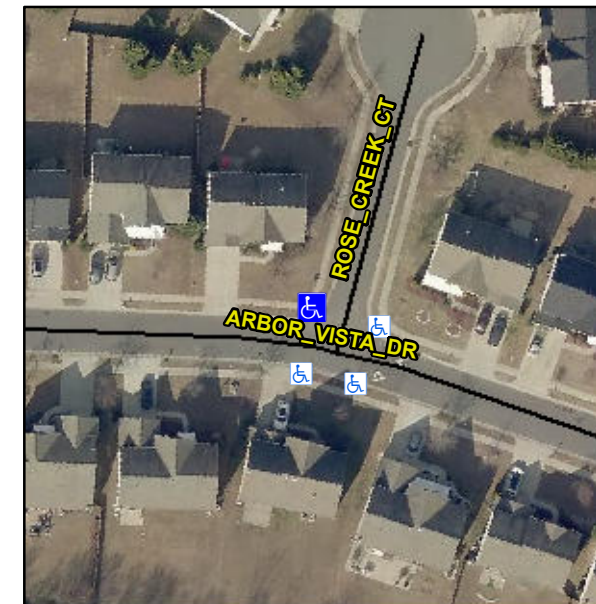
**Not Found, R304.5.1**

Compliance	Description	Data	Compliance	Description	Data
N/A	Ramp Length (in)	50.0	Yes	Ramp Slope (%)	6.8
No	Ramp Width (in)	36.0	Yes	Ramp XSlope (%)	1.8
N/A	Flare Type LT	N/A	N/A	Flare Type RT	N/A
N/A	Flare Slope LT (%)	N/A	N/A	Flare Slope RT (%)	N/A
N/A	Flare Traversable LT?	N/A	N/A	Flare Traversable RT?	N/A
N/A	Landing Length (in)	N/A	N/A	DWS Provided?	N/A
N/A	Landing Width (in)	N/A	N/A	DWS Contrast?	N/A
N/A	Landing Slope (%)	N/A	N/A	DWS Length (in)	N/A
N/A	Landing X Slope (%)	N/A	N/A	DWS Full Width?	N/A
N/A	Landing Curb? (Y/N)	N/A	N/A	DWS Offset (in)	N/A
N/A	Shared Landing?	N/A			
N/A	Gutter Ponding?	N/A	N/A	Gutter Slope (%)	N/A
N/A	Gutter Lip Ht (in)	N/A	N/A	Gutter X Slope (%)	N/A
N/A	Painted X Walk1?	No	N/A	Painted X Walk2?	No
	X Walk 1 Direction	To SW		X Walk 2 Direction	To SE
N/A	X Walk 1 Width (in)	N/A	N/A	X Walk 2 Width (in)	N/A
	X Walk 1 Slope (%)	0.6		X Walk 2 Slope (%)	1.5
	X Walk 1 X Slope (%)	0.9		X Walk 2 X Slope (%)	0.1

N/A	Ramp inside XWalk1?	N/A	N/A	Ramp inside XWalk2?	N/A
	Road Slope (%)	0.3	N/A	Clear Space?	N/A
	Road X Slope (%)	0.2	N/A	Clear Space to XWalk (in)	N/A
N/A	Any Obstructions?	N/A	N/A	Storm Grate/Utility Hazard?	N/A
	Obstruction Type			Storm Grate/Utility Type	
		N/A			N/A
		Yes		Surface Condition? (G/P)	Good

**Remove & Replace Curb Ramp With Two New Directional Ramps or Equivalent.**
