Access Compliance Report

Public Rights-of-Way

(Curb Ramps)

Intersection ID: 11707	Main Street: N_GRAHAM_ST	Cross Street: W_6TH_ST	Location: N
ADA ID: FA219C4D7BAE	Ramp Type: Directional1	Initial Pass/Fail: Fail	Overall Compliance: No
			Severity Score: 37.5

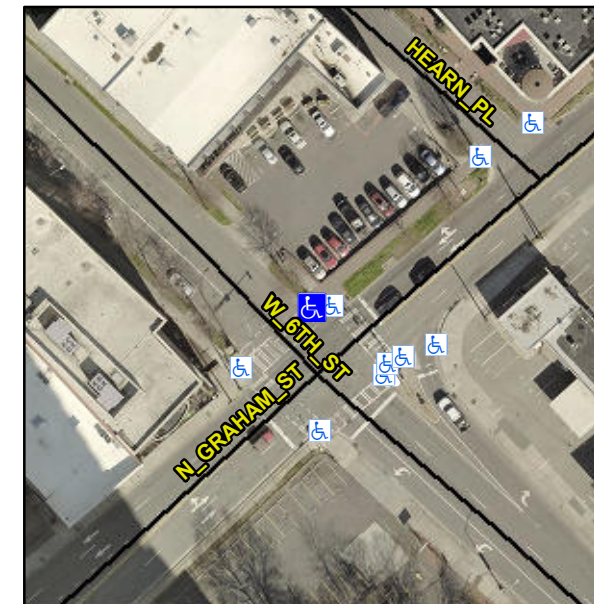
Compliance	Description	Data	Compliance	Description	Data
N/A	Ramp Length (in)	66.0	N/A	Grade Break?	N/A
Yes	Ramp Width (in)	48.0	N/A	Grade Break Slope (%)	0.0
No	Ramp Slope (%)	12.3	N/A	Grade Break XSlope (%)	0.0
No	Ramp XSlope (%)	5.7			
N/A	Flare Type LT	N/A	N/A	Flare Type RT	N/A
N/A	Flare Slope LT (%)	N/A	N/A	Flare Slope RT (%)	0.0
N/A	Flare Traversable LT?	N/A	N/A	Flare Traversable RT?	N/A
N/A	Landing Length (in)	0.0	N/A	DWS Provided?	N/A
N/A	Landing Width (in)	0.0	N/A	DWS Contrast?	N/A
N/A	Landing Slope (%)	0.0	N/A	DWS Length (in)	N/A
N/A	Landing X Slope (%)	0.0	N/A	DWS Full Width?	N/A
N/A	Landing Curb? (Y/N)	N/A	N/A	DWS Offset LT (in)	N/A
N/A	Shared Landing?	N/A	N/A	DWS Offset RT (in)	N/A
N/A	Gutter Ponding?	0.0	N/A	Gutter Slope (%)	N/A
N/A	Gutter Lip Ht (in)	0.0	N/A	Gutter X Slope (%)	N/A
N/A	Painted X Walk1?	Yes		Road Slope (%)	5.3
	X Walk 1 Direction	To SW		Road X Slope (%)	1.3
	X Walk 1 Width (in)	131.0		Clear Space?	N/A

X Walk 1 Slope (%)	5.3	N/A	Clear Space to XWalk (in)	N/A
	X Walk 1 X Slope (%)	1.3	N/A	Storm Grate/Utility Hazard?	N/A
N/A	Ramp inside XWalk1?	Yes		Storm Grate/Utility Type	
N/A	Any Obstructions?	N/A			N/A
	Obstruction Type		Yes	Surface Condition? (G/P)	Good
			N/A	Curb Slope (%)	14.8

Possible Solutions:

Remove & Replace Entire Ramp.

R304.2.2, R304.5.3
