# Access Compliance Report

## Public Rights-of-Way

### (Curb Ramps)

Intersection ID: 17650	Main Street: CRESTHILL_DR	Cross Street: IDLEWILD_RD	Location:	N
ADA ID: FA21A63D20A3	Ramp Type: Para	Initial Pass/Fail: Fail	Overall Compliance: No	Severity Score: 13.75
Codes/Mitigation Info/Possible Solution		Field Measurements/Component Compliance

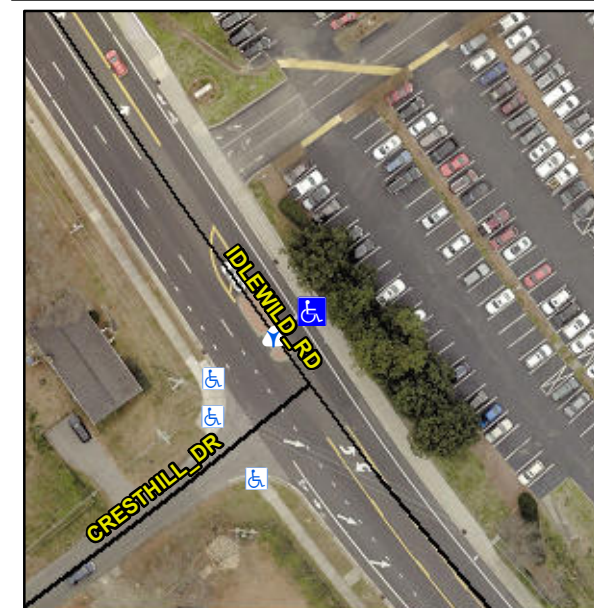
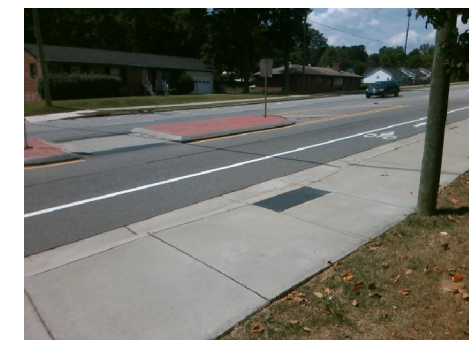
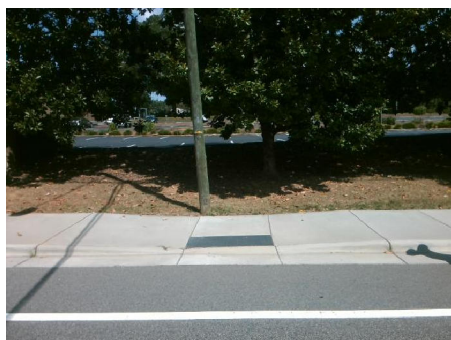
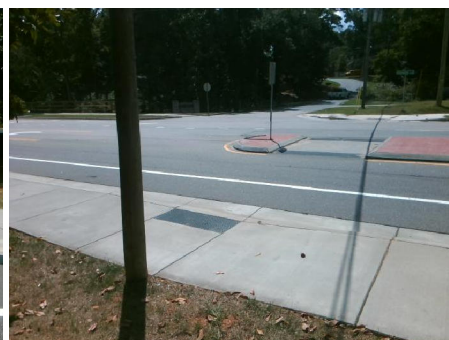
**RT RP < 5%**

**R304.3.2, R304.5.3**

Compliance	Description	Data	Compliance	Description	Data
N/A	Ramp Length LT (in)	95.0	N/A	Ramp Length RT (in)	73.0
Yes	Ramp Width LT (in)	84.0	Yes	Ramp Width RT (in)	84.0
No	Ramp Slope LT (%)	8.8	Yes	Ramp Slope RT (%)	1.2
Yes	Ramp XSlope LT (%)	2.0	No	Ramp XSlope RT (%)	2.1
N/A	Landing Length (in)	N/A	N/A	DWS Provided?	N/A
N/A	Landing Width (in)	N/A	N/A	DWS Contrast?	N/A
N/A	Landing Slope (%)	N/A	N/A	DWS Length (in)	N/A
N/A	Landing X Slope (%)	N/A	N/A	DWS Full Width?	N/A
N/A	Landing Curb? (Y/N)	N/A	N/A	DWS Offset (in)	N/A
N/A	Shared Landing?	N/A			
N/A	Gutter Ponding?	N/A	N/A	Gutter Slope (%)	N/A
N/A	Gutter Lip Ht (in)	N/A	N/A	Gutter X Slope (%)	N/A
N/A	Painted X Walk1?	No	N/A	Painted X Walk2?	N/A
	X Walk 1 Direction	To SW		X Walk 2 Direction	N/A
N/A	X Walk 1 Width (in)	N/A	N/A	X Walk 2 Width (in)	N/A
	X Walk 1 Slope (%)	1.8		X Walk 2 Slope (%)	N/A
	X Walk 1 X Slope (%)	3.4		X Walk 2 X Slope (%)	N/A
N/A	Ramp inside XWalk1?	N/A	N/A	Ramp inside XWalk2?	N/A

Road Slope (%)	N/A	N/A	Clear Space?	N/A
	Road X Slope (%)	N/A	N/A	Clear Space to XWalk (in)	N/A
N/A	Any Obstructions?	N/A	N/A	Storm Grate/Utility Hazard?	N/A
	Obstruction Type			Storm Grate/Utility Type	
		N/A			N/A
			Yes	Surface Condition? (G/P)	Good
			N/A	Curb Slope (%)	4.8

**Remove & Replace Entire Ramp.**
