Access Compliance Report Public Rights-of-Way (Curb Ramps)

Intersection ID: 53181 Main Street: GOODMAN_PARK_CT Cross Street: BASIE_PARK_CT Location: SE

ADA ID: FA21D5EA593A Ramp Type: Perp Initial Pass/Fail: Fail Overall Compliance: No Severity Score: 22.5

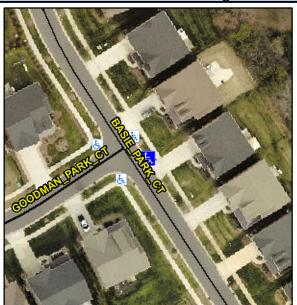
Possible Solutions:	<u>c</u>	
Remove & Replace Entire Ramp.		
•	N	
	N	
	N	
	N	
	N	
Surveyor Notes:	N	
N/A	N	
	N	
	N	
	N	
PROW/ADA:	N	
Not Found, R304.5.1, R304.2.2,	N	
R304.5.3	N	
	N

Field Measurements/Component Compliance								
Comp	liance Description	Data	Comp	liance Description	Data			
N/A	Ramp Length (in)	97.0	No	Ramp Slope (%)	8.8			
No	Ramp Width (in)	47.5	No	Ramp XSlope (%)	4.0			
N/A	Flare Type LT	N/A	N/A	Flare Type RT	N/A			
N/A	Flare Slope LT (%)	N/A	N/A	Flare Slope RT (%)	N/A			
N/A	Flare Traversable LT?	N/A	N/A	Flare Traversable RT?	N/A			
N/A	Landing Length (in)	N/A	N/A	DWS Provided?	N/A			
N/A	Landing Width (in)	N/A	N/A	DWS Contrast?	N/A			
N/A	Landing Slope (%)	N/A	N/A	DWS Length (in)	N/A			
N/A	Landing X Slope (%)	N/A	N/A	DWS Full Width?	N/A			
N/A	Landing Curb? (Y/N)	N/A	N/A	DWS Offset (in)	N/A			
N/A	Shared Landing?	N/A						
N/A	Gutter Ponding?	N/A	N/A	Gutter Slope (%)	N/A			
N/A	Gutter Lip Ht (in)	N/A	N/A	Gutter X Slope (%)	N/A			
N/A	Painted X Walk1?	No	N/A	Painted X Walk2?	N/A			
	X Walk 1 Direction	To SW		X Walk 2 Direction	N/A			
N/A	X Walk 1 Width (in)	N/A	N/A	X Walk 2 Width (in)	N/A

X Walk 1 Slope (%)	2.8		X Walk 2 Slope (%)	N/A			
	X Walk 1 X Slope (%)	3.9		X Walk 2 X Slope (%)	N/A			
N/A	Ramp inside XWalk1?	N/A	N/A	Ramp inside XWalk2?	N/A			
	Road Slope (%)	N/A	N/A	Clear Space?	N/A			
	Road X Slope (%)	N/A	N/A	Clear Space to XWalk (in)	N/A			
N/A	Any Obstructions?	N/A	N/A	Storm Grate/Utility Hazard?	N/A			
	Obstruction Type			Storm Grate/Utility Type				
		N/A			N/A			
			Yes	Surface Condition? (G/P)	Good

R304.5.3		
Total Cost:	\$ 1850.00
