# Access Compliance Report

## Public Rights-of-Way

### (Curb Ramps)

| Intersection ID: 3261 | Main Street: BILLINGHAM_DR | Cross Street: MCKENDREE_WY | Location: SE |

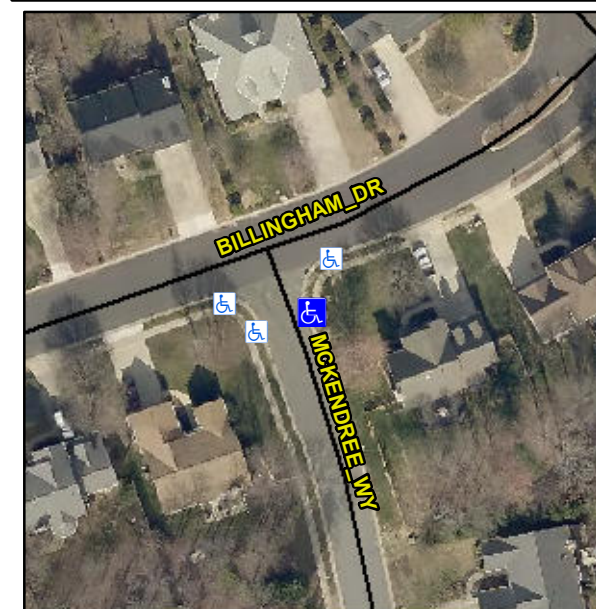
| ADA ID: FA25095E797A | Ramp Type: Perp | Initial Pass/Fail: Fail | Overall Compliance: No |

**Not Found, R304.5.3, R302.7**

| Compliance | Description | Data | Compliance | Description | Data |
|---|---|---|---|---|---|
| N/A | Ramp Length (in) | 47.0 | Yes | Ramp Slope (%) | 5.0 |
| Yes | Ramp Width (in) | 49.0 | No | Ramp XSlope (%) | 2.2 |
| | | No | | Surface Condition? (G/P) | Poor |

**Remove & Replace Entire Ramp.**
