Access Compliance Report

Public Rights-of-Way

(Curb Ramps)

Intersection ID: 12735	Main Street: FULTON_AV	Cross Street: KENSINGTON_DR	Location: SW
ADA ID: FA27AD26FCCE	Ramp Type: Perp	Initial Pass/Fail: Fail	Overall Compliance: No
Severity Score: 22.5			
Codes/Mitigation Info/Possible Solution		Field Measurements/Component Compliance

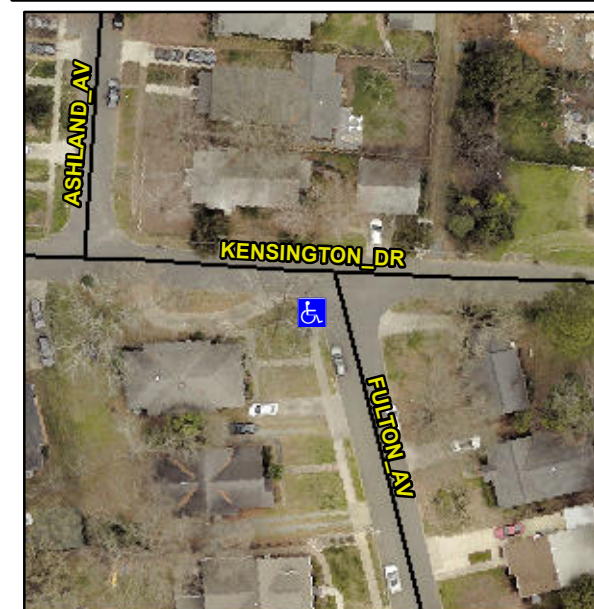
Compliance	Description	Data	Compliance	Description	Data
N/A	Ramp Length (in)	62.0	No	Ramp Slope (%)	10.3
No	Ramp Width (in)	36.0	Yes	Ramp XSlope (%)	3.4
N/A	Flare Type LT	N/A	N/A	Flare Type RT	N/A
N/A	Flare Slope LT (%)	N/A	N/A	Flare Slope RT (%)	N/A
N/A	Flare Traversable LT?	N/A	N/A	Flare Traversable RT?	N/A
N/A	Landing Length (in)	N/A	N/A	DWS Provided?	N/A
N/A	Landing Width (in)	N/A	N/A	DWS Contrast?	N/A
N/A	Landing Slope (%)	N/A	N/A	DWS Length (in)	N/A
N/A	Landing X Slope (%)	N/A	N/A	DWS Full Width?	N/A
N/A	Landing Curb? (Y/N)	N/A	N/A	DWS Offset (in)	N/A
N/A	Shared Landing?	N/A			
N/A	Gutter Ponding?	Yes	N/A	Gutter Slope (%)	N/A
N/A	Gutter Lip Ht (in)	N/A	N/A	Gutter X Slope (%)	N/A
N/A	Painted X Walk1?	No	N/A	Painted X Walk2?	N/A
	X Walk 1 Direction	To N		X Walk 2 Direction	N/A
N/A	X Walk 1 Width (in)	N/A	N/A	X Walk 2 Width (in)	N/A
	X Walk 1 Slope (%)	5.1		X Walk 2 Slope (%)	N/A
	X Walk 1 X Slope (%)	4.6		X Walk 2 X Slope (%)	N/A

N/A	Ramp inside XWalk1?	N/A	N/A	Ramp inside XWalk2?	N/A
	Road Slope (%)	4.6	N/A	Clear Space?	N/A
	Road X Slope (%)	5.1	N/A	Clear Space to XWalk (in)	N/A
N/A	Any Obstructions?	N/A	N/A	Storm Grate/Utility Hazard?	N/A
	Obstruction Type			Storm Grate/Utility Type	
		N/A			N/A
		Yes		Surface Condition? (G/P)	Good

Possible Solutions:

Remove & Replace Entire Ramp.

R304.5.1, R304.2.2
