Access Compliance Report

Public Rights-of-Way

(Curb Ramps)

Intersection ID: 32056	Main Street: AZALEA RIDGE RD	Cross Street: PROVIDENCE RD	Location: NW
ADA ID: FA3C251AAC98	Ramp Type: PerpDiag	Initial Pass/Fail: Fail	Overall Compliance: No
Severity Score: 22.5			
Codes/Mitigation Info/Possible Solution		Field Measurements/Component Compliance

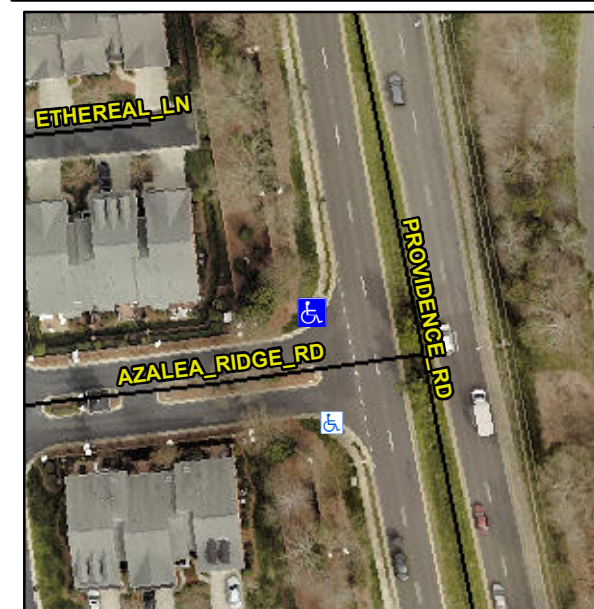
Not Found, R304.5.1, R304.2.2, R304.5.3

Compliance	Description	Data	Compliance	Description	Data
N/A	Ramp Length (in)	81.0	No	Ramp Slope (%)	8.9
No	Ramp Width (in)	38.0	No	Ramp XSlope (%)	3.9
N/A	Flare Type LT	N/A	N/A	Flare Type RT	N/A
N/A	Flare Slope LT (%)	N/A	N/A	Flare Slope RT (%)	N/A
N/A	Flare Traversable LT?	N/A	N/A	Flare Traversable RT?	N/A
N/A	Landing Length (in)	N/A	N/A	DWS Provided?	N/A
N/A	Landing Width (in)	N/A	N/A	DWS Contrast?	N/A
N/A	Landing Slope (%)	N/A	N/A	DWS Length (in)	N/A
N/A	Landing X Slope (%)	N/A	N/A	DWS Full Width?	N/A
N/A	Landing Curb? (Y/N)	N/A	N/A	DWS Offset (in)	N/A
N/A	Shared Landing?	N/A			
N/A	Gutter Ponding?	N/A	N/A	Gutter Slope (%)	N/A
N/A	Gutter Lip Ht (in)	N/A	N/A	Gutter X Slope (%)	N/A
N/A	Painted X Walk1?	No	N/A	Painted X Walk2?	No
	X Walk 1 Direction	To S		X Walk 2 Direction	To E
N/A	X Walk 1 Width (in)	N/A	N/A	X Walk 2 Width (in)	N/A
	X Walk 1 Slope (%)	0.9		X Walk 2 Slope (%)	2.4
	X Walk 1 X Slope (%)	4.4		X Walk 2 X Slope (%)	1.5

N/A	Ramp inside XWalk1?	N/A	N/A	Ramp inside XWalk2?	N/A
	Road Slope (%)	5.5	N/A	Clear Space?	N/A
	Road X Slope (%)	3.6	N/A	Clear Space to XWalk (in)	N/A
N/A	Any Obstructions?	N/A	N/A	Storm Grate/Utility Hazard?	N/A
	Obstruction Type			Storm Grate/Utility Type	
		N/A			N/A
			Yes	Surface Condition? (G/P)	Good

Remove & Replace Curb Ramp With Two New Directional Ramps or Equivalent.
