Access Compliance Report

Public Rights-of-Way

(Curb Ramps)

Intersection ID: 11423	Main Street: S_SUMMIT_AV	Cross Street: W_4TH_ST_EXT	Location: SE
ADA ID: FA406087FAC8	Ramp Type: Directional1	Initial Pass/Fail: Pass	Overall Compliance: No
		Severity Score: 0

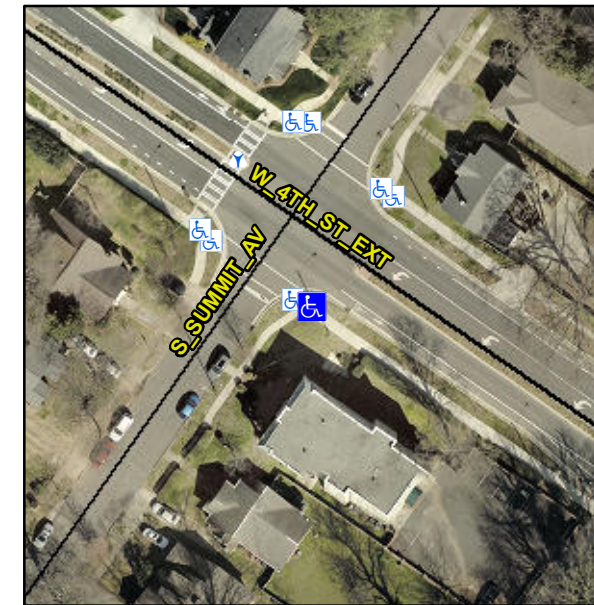
R304.5.3

Compliance	Description	Data	Compliance	Description	Data
N/A	Ramp Length (in)	54.5	Yes	Grade Break?	Yes
Yes	Ramp Width (in)	70.0	No	Grade Break Slope (%)	8.3
Yes	Ramp Slope (%)	5.1	No	Grade Break XSlope (%)	3.1
Yes	Ramp XSlope (%)	0.5			
Yes	Flare Type LT	N/A	Yes	Flare Type RT	N/A
N/A	Flare Slope LT (%)	N/A	N/A	Flare Slope RT (%)	N/A
N/A	Flare Traversable LT?	No	N/A	Flare Traversable RT?	No
Yes	Landing Length (in)	71.0	Yes	DWS Provided?	Yes
Yes	Landing Width (in)	72.0	Yes	DWS Contrast?	Yes
Yes	Landing Slope (%)	1.1	Yes	DWS Length (in)	24.0
Yes	Landing X Slope (%)	1.2	Yes	DWS Full Width?	Yes
N/A	Landing Curb? (Y/N)	No	Yes	DWS Offset LT (in)	18.0
N/A	Shared Landing?	Yes	Yes	DWS Offset RT (in)	0.0
Yes	Gutter Ponding?	No	Yes	Gutter Slope (%)	2.0
Yes	Gutter Lip Ht (in)	0.0	Yes	Gutter X Slope (%)	0.9
N/A	Painted X Walk1?	No		Road Slope (%)	2.3
	X Walk 1 Direction	To NE		Road X Slope (%)	2.6
	X Walk 1 Width (in)	N/A		Clear Space?	Yes

X Walk 1 Slope (%)	2.3	N/A	Clear Space to XWalk (in)	N/A
	X Walk 1 X Slope (%)	2.6	Yes	Storm Grate/Utility Hazard?	No
N/A	Ramp inside XWalk1?	N/A		Storm Grate/Utility Type	
Yes	Any Obstructions?	No			N/A
	Obstruction Type		Yes	Surface Condition? (G/P)	Good
			N/A	Curb Slope (%)	1.9

Remove & Replace Entire Ramp.
