# Access Compliance Report

## Public Rights-of-Way

### (Curb Ramps)

Intersection ID: 14071	Main Street: CLEVELAND_AV	Cross Street: E_KINGSTON_AV	Location: W
ADA ID: FA44B96719E3	Ramp Type: Perp	Initial Pass/Fail: Fail	Overall Compliance: No
Severity Score: 21.25			
Codes/Mitigation Info/Possible Solution		Field Measurements/Component Compliance

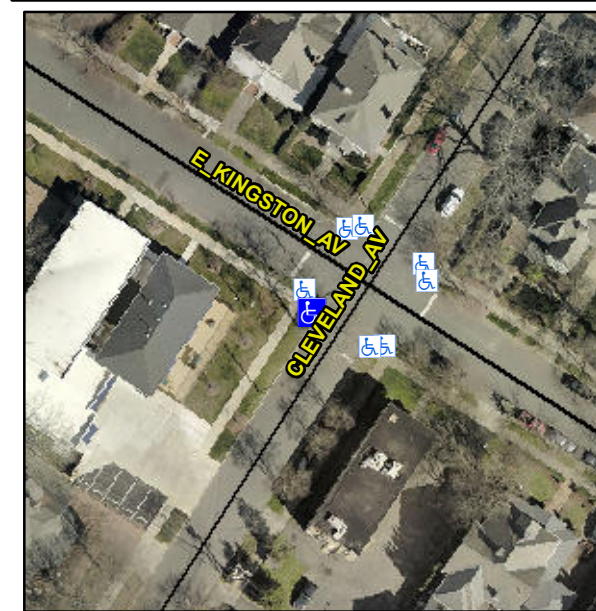
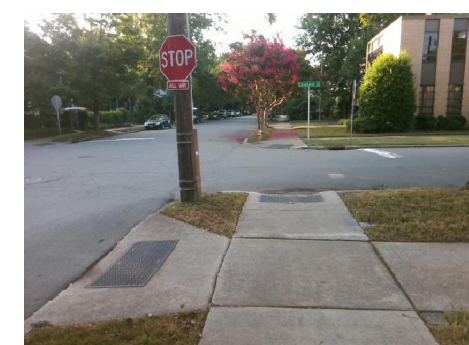
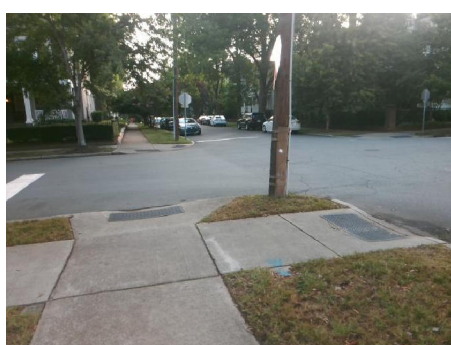
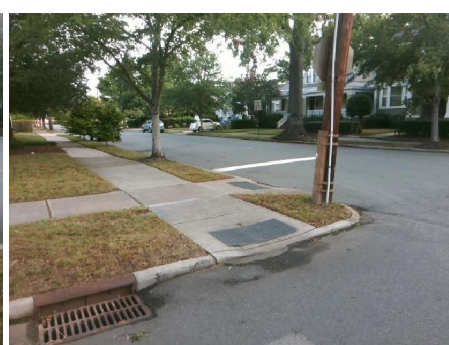
**R304.5.1, R304.5.3**

Compliance	Description	Data	Compliance	Description	Data
N/A	Ramp Length (in)	53.0	Yes	Ramp Slope (%)	7.4
No	Ramp Width (in)	36.0	No	Ramp XSlope (%)	5.1
N/A	Flare Type LT	N/A	N/A	Flare Type RT	N/A
N/A	Flare Slope LT (%)	N/A	N/A	Flare Slope RT (%)	N/A
N/A	Flare Traversable LT?	N/A	N/A	Flare Traversable RT?	N/A
N/A	Landing Length (in)	N/A	N/A	DWS Provided?	N/A
N/A	Landing Width (in)	N/A	N/A	DWS Contrast?	N/A
N/A	Landing Slope (%)	N/A	N/A	DWS Length (in)	N/A
N/A	Landing X Slope (%)	N/A	N/A	DWS Full Width?	N/A
N/A	Landing Curb? (Y/N)	N/A	N/A	DWS Offset (in)	N/A
N/A	Shared Landing?	N/A			
N/A	Gutter Ponding?	N/A	N/A	Gutter Slope (%)	N/A
N/A	Gutter Lip Ht (in)	1.0	N/A	Gutter X Slope (%)	N/A
N/A	Painted X Walk1?	No	N/A	Painted X Walk2?	N/A
	X Walk 1 Direction	To SE		X Walk 2 Direction	N/A
N/A	X Walk 1 Width (in)	N/A	N/A	X Walk 2 Width (in)	N/A
	X Walk 1 Slope (%)	4.3		X Walk 2 Slope (%)	N/A
	X Walk 1 X Slope (%)	0.1		X Walk 2 X Slope (%)	N/A

N/A	Ramp inside XWalk1?	N/A	N/A	Ramp inside XWalk2?	N/A
	Road Slope (%)	N/A	N/A	Clear Space?	N/A
	Road X Slope (%)	N/A	N/A	Clear Space to XWalk (in)	N/A
N/A	Any Obstructions?	N/A	N/A	Storm Grate/Utility Hazard?	N/A
	Obstruction Type			Storm Grate/Utility Type	
		N/A			N/A
			Yes	Surface Condition? (G/P)	Good

**Remove & Replace Entire Ramp.**

Total Cost: \$ 1850.00
