Access Compliance Report

Public Rights-of-Way

(Curb Ramps)

Intersection ID: 46488	Main Street: LAUDER_CT	Cross Street: BALLYBAY_DR	Location: NW
ADA ID: FA5D78F4BBF7	Ramp Type: BlendTrans1	Initial Pass/Fail: Fail	Overall Compliance: No
Severity Score: 12.5			
Codes/Mitigation Info/Possible Solution		Field Measurements/Component Compliance

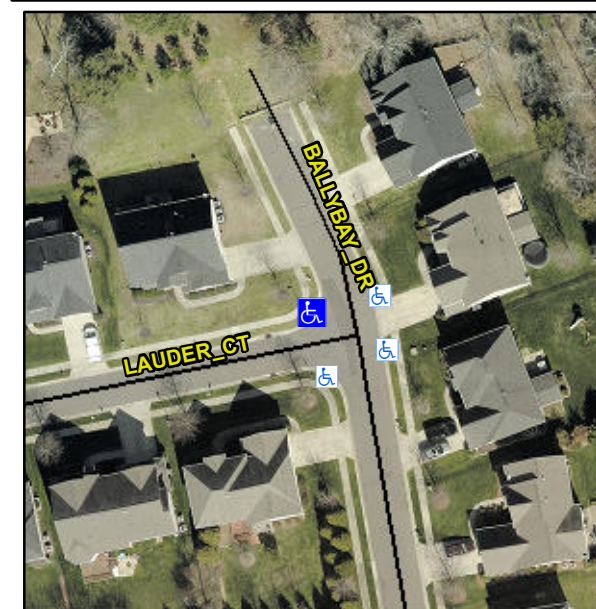
Compliance	Description	Data	Compliance	Description	Data
N/A	Ramp Length (in)	49.0	Yes	BlendTrans Slope (%)	2.7
Yes	Ramp Width (in)	48.0	No	BlendTrans XSlope (%)	5.1
N/A	Flare Type LT	N/A	N/A	Flare Type RT	N/A
N/A	Flare Slope LT (%)	N/A	N/A	Flare Slope RT (%)	N/A
N/A	Flare Traversable LT?	N/A	N/A	Flare Traversable RT?	N/A
N/A	Landing Length (in)	N/A	N/A	DWS Provided?	N/A
N/A	Landing Width (in)	N/A	N/A	DWS Contrast?	N/A
N/A	Landing Slope (%)	N/A	N/A	DWS Length (in)	N/A
N/A	Landing X Slope (%)	N/A	N/A	DWS Full Width?	N/A
N/A	Landing Curb? (Y/N)	N/A	N/A	DWS Offset (in)	N/A
N/A	Shared Landing?	N/A			
N/A	Gutter Ponding?	N/A	N/A	Gutter Slope (%)	N/A
N/A	Gutter Lip Ht (in)	N/A	N/A	Gutter X Slope (%)	N/A
N/A	Painted X Walk1?	No	N/A	Painted X Walk2?	No
	X Walk 1 Direction	To SE		X Walk 2 Direction	To NE
	X Walk 1 Width (in)	N/A		X Walk 2 Width (in)	N/A
	X Walk 1 Slope (%)	3.1		X Walk 2 Slope (%)	6.5
	X Walk 1 X Slope (%)	6.5		X Walk 2 X Slope (%)	1.2

N/A	Ramp inside XWalk1?	N/A	N/A	Ramp inside XWalk2?	N/A
	Road Slope (%)	3.7		Clear Space?	N/A
	Road X Slope (%)	5.1	N/A	Clear Space to XWalk (in)	N/A
N/A	Any Obstructions?	N/A	N/A	Storm Grate/Utility Hazard?	N/A
	Obstruction Type			Storm Grate/Utility Type	
		N/A			N/A
			Yes	Surface Condition? (G/P)	Good
			N/A	Curb Slope (%)	4.3

Possible Solutions:

Remove & Replace Curb Ramp With Two New Directional Ramps or Equivalent.

R304.5.3
