Access Compliance Report

Public Rights-of-Way

(Curb Ramps)

Intersection ID: 30490	Main Street: BRAMWYCK_DR	Cross Street: QUAIL_PARK_DR	Location: NW
ADA ID: FA5D7DA012FC	Ramp Type: PerpDiag	Initial Pass/Fail: Fail	Overall Compliance: No
Severity Score: 10			
Codes/Mitigation Info/Possible Solution		Field Measurements/Component Compliance

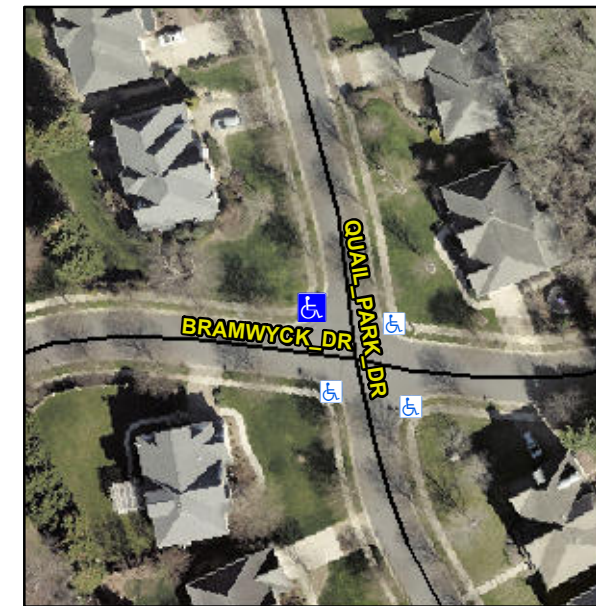
Compliance	Description	Data	Compliance	Description	Data
N/A	Ramp Length (in)	49.0	Yes	Ramp Slope (%)	5.6
No	Ramp Width (in)	39.0	No	Ramp XSlope (%)	2.5
N/A	Flare Type LT	N/A	N/A	Flare Type RT	N/A
N/A	Flare Slope LT (%)	N/A	N/A	Flare Slope RT (%)	N/A
N/A	Flare Traversable LT?	N/A	N/A	Flare Traversable RT?	N/A
N/A	Landing Length (in)	N/A	N/A	DWS Provided?	N/A
N/A	Landing Width (in)	N/A	N/A	DWS Contrast?	N/A
N/A	Landing Slope (%)	N/A	N/A	DWS Length (in)	N/A
N/A	Landing X Slope (%)	N/A	N/A	DWS Full Width?	N/A
N/A	Landing Curb? (Y/N)	N/A	N/A	DWS Offset (in)	N/A
N/A	Shared Landing?	N/A			
N/A	Gutter Ponding?	N/A	N/A	Gutter Slope (%)	N/A
N/A	Gutter Lip Ht (in)	N/A	N/A	Gutter X Slope (%)	N/A
N/A	Painted X Walk1?	No	N/A	Painted X Walk2?	No
	X Walk 1 Direction	To S		X Walk 2 Direction	To SE
N/A	X Walk 1 Width (in)	N/A	N/A	X Walk 2 Width (in)	N/A
	X Walk 1 Slope (%)	4.8		X Walk 2 Slope (%)	2.4
	X Walk 1 X Slope (%)	3.0		X Walk 2 X Slope (%)	2.4

N/A	Ramp inside XWalk1?	N/A	N/A	Ramp inside XWalk2?	N/A
	Road Slope (%)	0.8	N/A	Clear Space?	N/A
	Road X Slope (%)	3.7	N/A	Clear Space to XWalk (in)	N/A
N/A	Any Obstructions?	N/A	N/A	Storm Grate/Utility Hazard?	N/A
	Obstruction Type			Storm Grate/Utility Type	
		N/A			N/A
			Yes	Surface Condition? (G/P)	Good

Possible Solutions:

Remove & Replace Curb Ramp With Two New Directional Ramps or Equivalent.

PROW/ADA:

R304.5.1, R304.5.3
