Access Compliance Report

Public Rights-of-Way

(Curb Ramps)

Intersection ID: 48767	Main Street: TURNING_WHEEL_DR	Cross Street: MINITREE_LN	Location: NE
ADA ID: FA66B11C4892	Ramp Type: PerpDiag	Initial Pass/Fail: Fail	Overall Compliance: No
Severity Score: 10			
Codes/Mitigation Info/Possible Solution		Field Measurements/Component Compliance

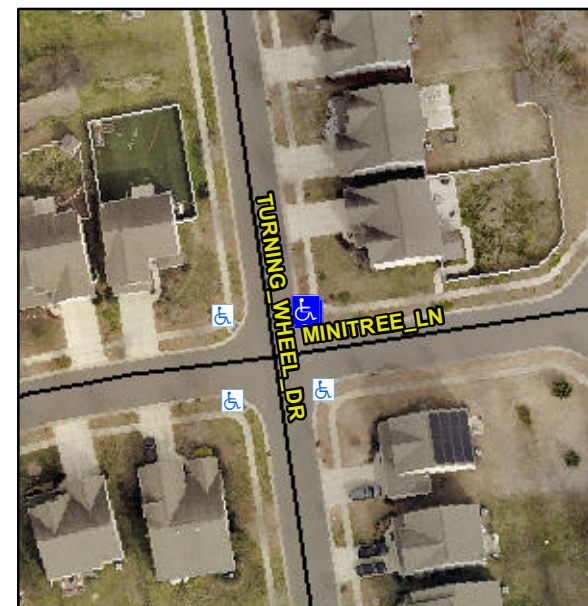
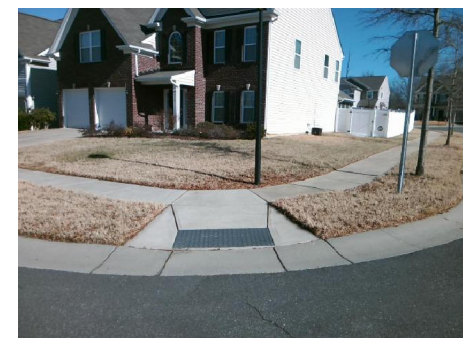
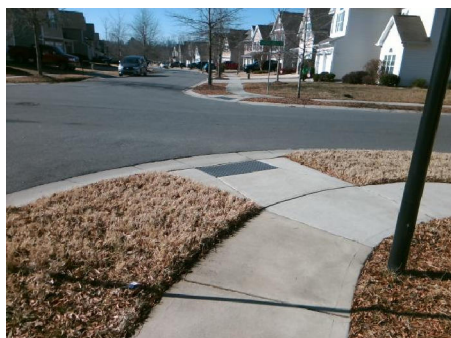
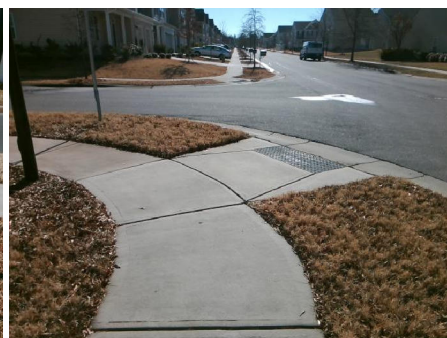
Not Found, R304.5.1, R304.5.3

Compliance	Description	Data	Compliance	Description	Data
N/A	Ramp Length (in)	73.0	Yes	Ramp Slope (%)	5.4
No	Ramp Width (in)	47.0	No	Ramp XSlope (%)	2.6
N/A	Flare Type LT	N/A	N/A	Flare Type RT	N/A
N/A	Flare Slope LT (%)	N/A	N/A	Flare Slope RT (%)	N/A
N/A	Flare Traversable LT?	N/A	N/A	Flare Traversable RT?	N/A
N/A	Landing Length (in)	N/A	N/A	DWS Provided?	N/A
N/A	Landing Width (in)	N/A	N/A	DWS Contrast?	N/A
N/A	Landing Slope (%)	N/A	N/A	DWS Length (in)	N/A
N/A	Landing X Slope (%)	N/A	N/A	DWS Full Width?	N/A
N/A	Landing Curb? (Y/N)	N/A	N/A	DWS Offset (in)	N/A
N/A	Shared Landing?	N/A			
N/A	Gutter Ponding?	N/A	N/A	Gutter Slope (%)	N/A
N/A	Gutter Lip Ht (in)	N/A	N/A	Gutter X Slope (%)	N/A
N/A	Painted X Walk1?	No	N/A	Painted X Walk2?	No
	X Walk 1 Direction	To W		X Walk 2 Direction	To S
N/A	X Walk 1 Width (in)	N/A	N/A	X Walk 2 Width (in)	N/A
	X Walk 1 Slope (%)	0.3		X Walk 2 Slope (%)	0.7
	X Walk 1 X Slope (%)	1.0		X Walk 2 X Slope (%)	2.1

N/A	Ramp inside XWalk1?	N/A	N/A	Ramp inside XWalk2?	N/A
	Road Slope (%)	2.0	N/A	Clear Space?	N/A
	Road X Slope (%)	0.6	N/A	Clear Space to XWalk (in)	N/A
N/A	Any Obstructions?	N/A	N/A	Storm Grate/Utility Hazard?	N/A
	Obstruction Type			Storm Grate/Utility Type	
		N/A			N/A
			Yes	Surface Condition? (G/P)	Good

Possible Solutions:

Remove & Replace Curb Ramp With Two New Directional Ramps or Equivalent.
