Access Compliance Report

Public Rights-of-Way

(Curb Ramps)

Intersection ID: 12570	Main Street: HARRISBURG_RD	Cross Street: STARNES_RANDALL_RD	Location:	N
ADA ID: FA69926D693A	Ramp Type: Perp	Initial Pass/Fail: Fail	Overall Compliance: No	Severity Score: 10
Codes/Mitigation Info/Possible Solution		Field Measurements/Component Compliance

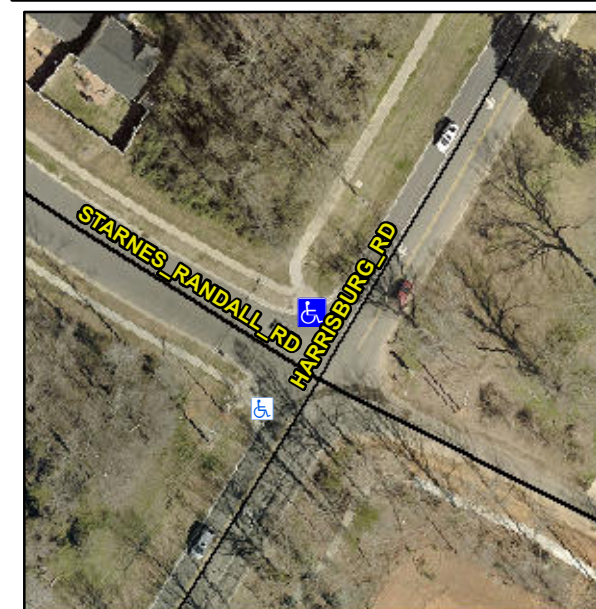
Not Found, R304.5.1, R304.5.3

Compliance	Description	Data	Compliance	Description	Data
N/A	Ramp Length (in)	87.5	Yes	Ramp Slope (%)	5.1
No	Ramp Width (in)	37.0	No	Ramp XSlope (%)	3.7
N/A	Flare Type LT	N/A	N/A	Flare Type RT	N/A
N/A	Flare Slope LT (%)	N/A	N/A	Flare Slope RT (%)	N/A
N/A	Flare Traversable LT?	N/A	N/A	Flare Traversable RT?	N/A
N/A	Landing Length (in)	N/A	N/A	DWS Provided?	N/A
N/A	Landing Width (in)	N/A	N/A	DWS Contrast?	N/A
N/A	Landing Slope (%)	N/A	N/A	DWS Length (in)	N/A
N/A	Landing X Slope (%)	N/A	N/A	DWS Full Width?	N/A
N/A	Landing Curb? (Y/N)	N/A	N/A	DWS Offset (in)	N/A
N/A	Shared Landing?	N/A			
N/A	Gutter Ponding?	N/A	N/A	Gutter Slope (%)	N/A
N/A	Gutter Lip Ht (in)	N/A	N/A	Gutter X Slope (%)	N/A
N/A	Painted X Walk1?	No	N/A	Painted X Walk2?	N/A
	X Walk 1 Direction	To SW		X Walk 2 Direction	N/A
N/A	X Walk 1 Width (in)	N/A	N/A	X Walk 2 Width (in)	N/A
	X Walk 1 Slope (%)	1.6		X Walk 2 Slope (%)	N/A
	X Walk 1 X Slope (%)	2.9		X Walk 2 X Slope (%)	N/A

N/A	Ramp inside XWalk1?	N/A	N/A	Ramp inside XWalk2?	N/A
	Road Slope (%)	N/A	N/A	Clear Space?	N/A
	Road X Slope (%)	N/A	N/A	Clear Space to XWalk (in)	N/A
N/A	Any Obstructions?	N/A	N/A	Storm Grate/Utility Hazard?	N/A
	Obstruction Type			Storm Grate/Utility Type	
		N/A			N/A
			Yes	Surface Condition? (G/P)	Good

Remove & Replace Entire Ramp.
