# Access Compliance Report

## Public Rights-of-Way

| Intersection ID: N/A | Main Street: NATIONS_CROSSING_RD | Cross Street: N/A | Location: | E |
| ADA ID: FA7854A01CC2 | Ramp Type: Perp | Initial Pass/Fail: Fail | Overall Compliance: No | Severity Score: 12.5 |

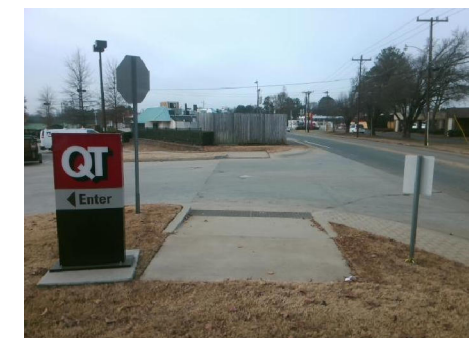
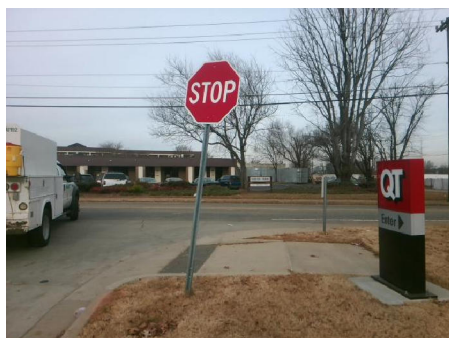
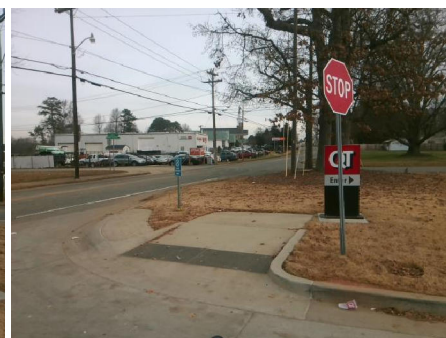
**Not Found, R304.2.2**

| Compliance | Description | Data | Compliance | Description | Data |
|---|---|---|---|---|---|
| N/A | Ramp Length (in) | 78.0 | No | Ramp Slope (%) | 8.5 |

**Remove & Replace Entire Ramp.**

Total Cost: \$ 1850.00
