Access Compliance Report

Public Rights-of-Way

(Curb Ramps)

Intersection ID: 9658	Main Street: VANDERBILT_RD	Cross Street: WOODWARD_AV	Location: NE
ADA ID: FA7F227DADA2	Ramp Type: Para	Initial Pass/Fail: Fail	Overall Compliance: No
Codes/Mitigation Info/Possible Solution		Field Measurements/Component Compliance

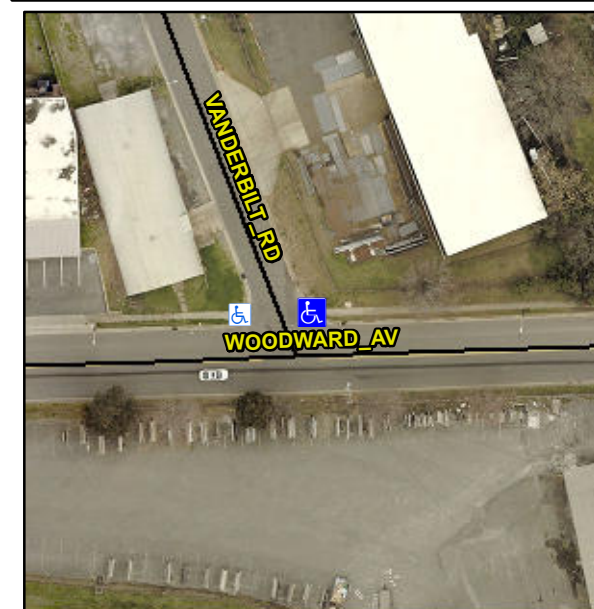
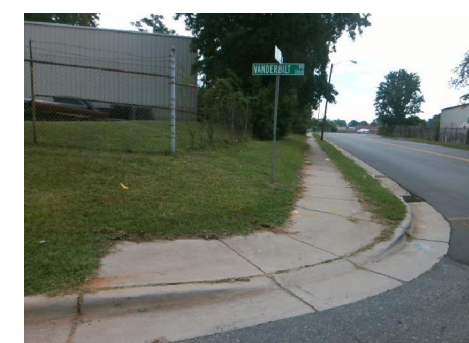
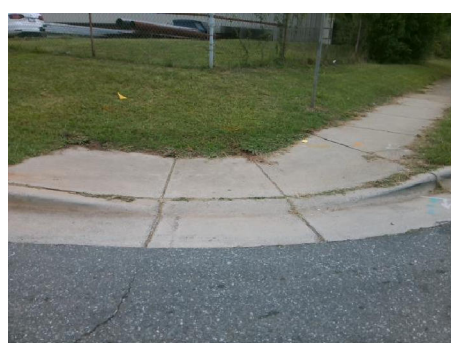
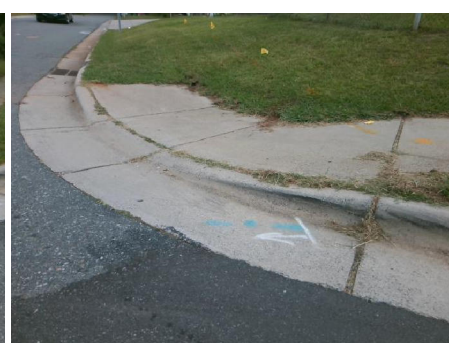
CURB GAP 1.0

R304.5.3, R304.3.2

Compliance	Description	Data	Compliance	Description	Data
N/A	Ramp Length LT (in)	55.0	N/A	Ramp Length RT (in)	46.0
Yes	Ramp Width LT (in)	52.5	Yes	Ramp Width RT (in)	58.0
Yes	Ramp Slope LT (%)	6.5	No	Ramp Slope RT (%)	11.5
No	Ramp XSlope LT (%)	3.4	Yes	Ramp XSlope RT (%)	0.6
N/A	Landing Length (in)	N/A	N/A	DWS Provided?	N/A
N/A	Landing Width (in)	N/A	N/A	DWS Contrast?	N/A
N/A	Landing Slope (%)	N/A	N/A	DWS Length (in)	N/A
N/A	Landing X Slope (%)	N/A	N/A	DWS Full Width?	N/A
N/A	Landing Curb? (Y/N)	N/A	N/A	DWS Offset (in)	N/A
N/A	Shared Landing?	N/A			
N/A	Gutter Ponding?	N/A	N/A	Gutter Slope (%)	N/A
N/A	Gutter Lip Ht (in)	N/A	N/A	Gutter X Slope (%)	N/A
N/A	Painted X Walk1?	No	N/A	Painted X Walk2?	N/A
	X Walk 1 Direction	To W		X Walk 2 Direction	N/A
N/A	X Walk 1 Width (in)	N/A	N/A	X Walk 2 Width (in)	N/A
	X Walk 1 Slope (%)	1.7		X Walk 2 Slope (%)	N/A
	X Walk 1 X Slope (%)	0.5		X Walk 2 X Slope (%)	N/A
N/A	Ramp inside XWalk1?	N/A	N/A	Ramp inside XWalk2?	N/A

Road Slope (%)	N/A	N/A	Clear Space?	N/A
	Road X Slope (%)	N/A	N/A	Clear Space to XWalk (in)	N/A
N/A	Any Obstructions?	N/A	N/A	Storm Grate/Utility Hazard?	N/A
	Obstruction Type			Storm Grate/Utility Type	
		N/A			N/A
			Yes	Surface Condition? (G/P)	Good
			N/A	Curb Slope (%)	21.9

Remove & Replace Entire Ramp.

Total Cost: \$ 1600.00
