## Access Compliance Report Public Rights-of-Way (Curb Ramps)

Intersection ID: 18820 Main Street: SEVENTY\_SEVEN\_CENTER\_DRCross Street: TYVOLA\_RD Location: NE

ADA ID: FA7F44ECE766 Ramp Type: PerpDiag Initial Pass/Fail: Fail Overall Compliance: No Severity Score: 12.5

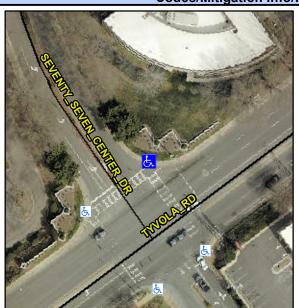
Compliance Description		Data	Compliance		Description	Data
N/A	Ramp Length (in)	49.0	Yes	Ramp	Slope (%)	6.6
Yes	Ramp Width (in)	56.0	No	Ramp XSlope (%)		5.4
N/A	Flare Type LT	N/A	N/A	Flare	Flare Type RT	
N/A	Flare Slope LT (%)	N/A	N/A	Flare Slope RT (%)		N/A
N/A	Flare Traversable LT?	N/A	N/A	Flare	Traversable RT?	N/A
N/A	Landing Length (in)	N/A	N/A	DWS	Provided?	N/A
N/A	Landing Width (in)	N/A	N/A	DWS	Contrast?	N/A
N/A	Landing Slope (%)	N/A	N/A	DWS	Length (in)	N/A
N/A	Landing X Slope (%)	N/A	N/A	DWS	Full Width?	N/A
N/A	Landing Curb? (Y/N)	N/A	N/A	DWS	Offset (in)	N/A
N/A	Shared Landing?	N/A				
N/A	Gutter Ponding?	N/A	N/A	Gutte	r Slope (%)	N/A
N/A	Gutter Lip Ht (in)	N/A	N/A	Gutte	r X Slope (%)	N/A
N/A	Painted X Walk1?	Yes	N/A	Painte	ed X Walk2?	Yes
	X Walk 1 Direction	To SW		X Wa	lk 2 Direction	To SE
N/A	X Walk 1 Width (in)	106.0	N/A	X Wa	lk 2 Width (in)	105.0
	X Walk 1 Slope (%)	1.1		X Wa	lk 2 Slope (%)	4.1

X Walk 1 X Slope (%)	5.3		X Wa	lk 2 X Slope (%)	0.7
N/A	Ramp inside XWalk1?	Yes	N/A	Ramp	inside XWalk2?	Yes
	Road Slope (%)	4.6	N/A	Clear	Space?	N/A
	Road X Slope (%)	2.6	N/A	Clear	Space to XWalk (in)	N/A
N/A	Any Obstructions?	N/A	N/A	Storm	n Grate/Utility Hazard?	N/A
	Obstruction Type			Storm	n Grate/Utility Type	
		N/A				N/A
			Yes	Surfa	ce Condition? (G/P)	Good

Remove & Replace Curb Ramp With Two New Directional Ramps or Equivalent.

R304.5.3
