Access Compliance Report

Public Rights-of-Way

(Curb Ramps)

Intersection ID: 10011809	Main Street: STATESVILLE_RD	Cross Street: N/A	Location: NE
ADA ID: FA8900FD4B05	Ramp Type: Perp	Initial Pass/Fail: Fail	Overall Compliance: No
Severity Score: 8.75			
Codes/Mitigation Info/Possible Solution		Field Measurements/Component Compliance

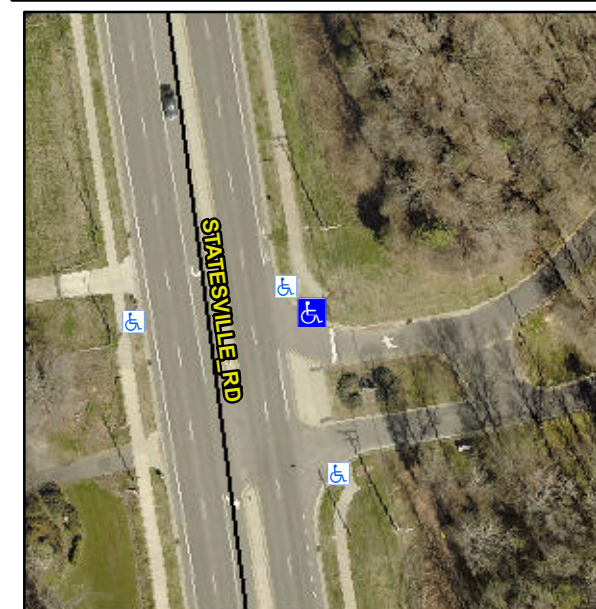
Not Found, R304.5.1

Compliance	Description	Data	Compliance	Description	Data
N/A	Ramp Length (in)	102.0	Yes	Ramp Slope (%)	6.8
No	Ramp Width (in)	47.0	Yes	Ramp XSlope (%)	0.2
N/A	Flare Type LT	N/A	N/A	Flare Type RT	N/A
N/A	Flare Slope LT (%)	N/A	N/A	Flare Slope RT (%)	N/A
N/A	Flare Traversable LT?	N/A	N/A	Flare Traversable RT?	N/A
N/A	Landing Length (in)	N/A	N/A	DWS Provided?	N/A
N/A	Landing Width (in)	N/A	N/A	DWS Contrast?	N/A
N/A	Landing Slope (%)	N/A	N/A	DWS Length (in)	N/A
N/A	Landing X Slope (%)	N/A	N/A	DWS Full Width?	N/A
N/A	Landing Curb? (Y/N)	N/A	N/A	DWS Offset (in)	N/A
N/A	Shared Landing?	N/A			
N/A	Gutter Ponding?	N/A	N/A	Gutter Slope (%)	N/A
N/A	Gutter Lip Ht (in)	N/A	N/A	Gutter X Slope (%)	N/A
N/A	Painted X Walk1?	No	N/A	Painted X Walk2?	N/A
	X Walk 1 Direction	To S		X Walk 2 Direction	N/A
N/A	X Walk 1 Width (in)	N/A	N/A	X Walk 2 Width (in)	N/A
	X Walk 1 Slope (%)	1.0		X Walk 2 Slope (%)	N/A
	X Walk 1 X Slope (%)	0.4		X Walk 2 X Slope (%)	N/A

N/A	Ramp inside XWalk1?	N/A	N/A	Ramp inside XWalk2?	N/A
	Road Slope (%)	N/A	N/A	Clear Space?	N/A
	Road X Slope (%)	N/A	N/A	Clear Space to XWalk (in)	N/A
N/A	Any Obstructions?	N/A	N/A	Storm Grate/Utility Hazard?	N/A
	Obstruction Type			Storm Grate/Utility Type	
		N/A			N/A
			Yes	Surface Condition? (G/P)	Good

Remove & Replace Entire Ramp.
