Access Compliance Report Public Rights-of-Way (Curb Ramps)

Intersection ID: 12450 Main Street: N_ALEXANDER_ST Cross Street: E_9TH_ST Location: S

ADA ID: FA940C9F881E Ramp Type: PerpDiag Initial Pass/Fail: Fail Overall Compliance: No Severity Score: 35

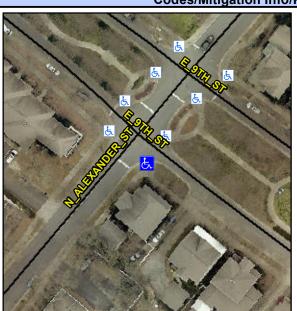
Not Found, R304.5.1, R304.2.2, R304.5.3

Compliance Description Data			Compliance Description		Data
N/A	Ramp Length (in)	72.0	No	Ramp Slope (%)	12.5
No	Ramp Width (in)	42.0	No	Ramp XSlope (%)	4.7
N/A	Flare Type LT	N/A	N/A	Flare Type RT	N/A
N/A	Flare Slope LT (%)	N/A	N/A	Flare Slope RT (%)	N/A
N/A	Flare Traversable LT?	N/A	N/A	Flare Traversable RT?	N/A
N/A	Landing Length (in)	N/A	N/A	DWS Provided?	N/A
N/A	Landing Width (in)	N/A	N/A	DWS Contrast?	N/A
N/A	Landing Slope (%)	N/A	N/A	DWS Length (in)	N/A
N/A	Landing X Slope (%)	N/A	N/A	DWS Full Width?	N/A
N/A	Landing Curb? (Y/N)	N/A	N/A	DWS Offset (in)	N/A
N/A	Shared Landing?	N/A			
N/A	Gutter Ponding?	N/A	N/A	Gutter Slope (%)	N/A
N/A	Gutter Lip Ht (in)	N/A	N/A	Gutter X Slope (%)	N/A
N/A	Painted X Walk1?	No	N/A	Painted X Walk2?	No
	X Walk 1 Direction	To NE		X Walk 2 Direction	To NW
N/A	X Walk 1 Width (in)	N/A	N/A	X Walk 2 Width (in)	N/A
	X Walk 1 Slope (%)	0.4		X Walk 2 Slope (%)	1.3
	X Walk 1 X Slope (%)	4.2		X Walk 2 X Slope (%)	2.3

N/A	Ramp inside XWalk1?	N/A	N/A	Ramp inside XWalk2?	N/A
	Road Slope (%)	5.9	N/A	Clear Space?	N/A
	Road X Slope (%)	0.6	N/A	Clear Space to XWalk (in)	N/A
	rtodd it Glope (70)	0.0	17/7	Oldar Opado to Avvail (III)	•

Remove & Replace Curb Ramp With Two New Directional Ramps or Equivalent.
