# Access Compliance Report

## Public Rights-of-Way

### (Curb Ramps)

Intersection ID: 21596	Main Street: HARDISON_RD	Cross Street: SHARON_VIEW_RD	Location: SE
ADA ID: FA9E9F467DEF	Ramp Type: PerpDiag	Initial Pass/Fail: Fail	Overall Compliance: No
		Severity Score: 42.5

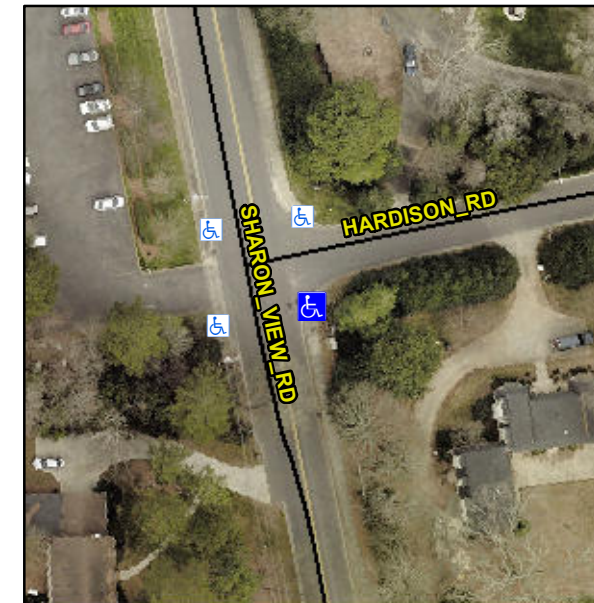
**Not Found, R304.5.1, R304.2.2, R304.5.3**

Compliance	Description	Data	Compliance	Description	Data
N/A	Ramp Length (in)	71.0	No	Ramp Slope (%)	9.6
No	Ramp Width (in)	33.0	No	Ramp XSlope (%)	6.6
N/A	Flare Type LT	N/A	N/A	Flare Type RT	N/A
N/A	Flare Slope LT (%)	N/A	N/A	Flare Slope RT (%)	N/A
N/A	Flare Traversable LT?	N/A	N/A	Flare Traversable RT?	N/A
N/A	Landing Length (in)	N/A	N/A	DWS Provided?	N/A
N/A	Landing Width (in)	N/A	N/A	DWS Contrast?	N/A
N/A	Landing Slope (%)	N/A	N/A	DWS Length (in)	N/A
N/A	Landing X Slope (%)	N/A	N/A	DWS Full Width?	N/A
N/A	Landing Curb? (Y/N)	N/A	N/A	DWS Offset (in)	N/A
N/A	Shared Landing?	N/A			
N/A	Gutter Ponding?	N/A	N/A	Gutter Slope (%)	N/A
N/A	Gutter Lip Ht (in)	N/A	N/A	Gutter X Slope (%)	N/A
N/A	Painted X Walk1?	No	N/A	Painted X Walk2?	No
	X Walk 1 Direction	To N		X Walk 2 Direction	To W
N/A	X Walk 1 Width (in)	N/A	N/A	X Walk 2 Width (in)	N/A
	X Walk 1 Slope (%)	0.4		X Walk 2 Slope (%)	7.6
	X Walk 1 X Slope (%)	6.7		X Walk 2 X Slope (%)	1.5

N/A	Ramp inside XWalk1?	N/A	N/A	Ramp inside XWalk2?	N/A
	Road Slope (%)	6.2	N/A	Clear Space?	N/A
	Road X Slope (%)	2.1	N/A	Clear Space to XWalk (in)	N/A
N/A	Any Obstructions?	N/A	N/A	Storm Grate/Utility Hazard?	N/A
	Obstruction Type			Storm Grate/Utility Type	
		N/A			N/A
			Yes	Surface Condition? (G/P)	Good

**Remove & Replace Curb Ramp With Two New Directional Ramps or Equivalent.**

Total Cost: \$ 3200.00
