Access Compliance Report

Public Rights-of-Way

(Curb Ramps)

Intersection ID: 20593	Main Street: BROAD_OAK_DR	Cross Street: RED_HICKORY_LN	Location: NW
ADA ID: FAAA6EEA9466	Ramp Type: Directional1	Initial Pass/Fail: Fail	Overall Compliance: No
Severity Score: 12.5			
Codes/Mitigation Info/Possible Solution		Field Measurements/Component Compliance

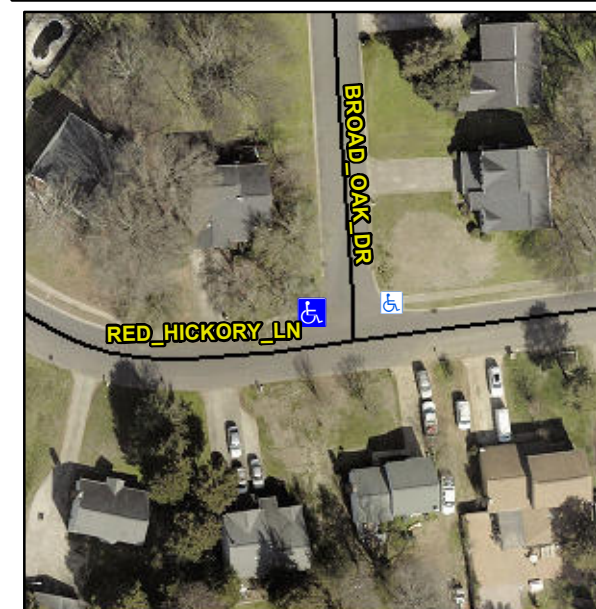
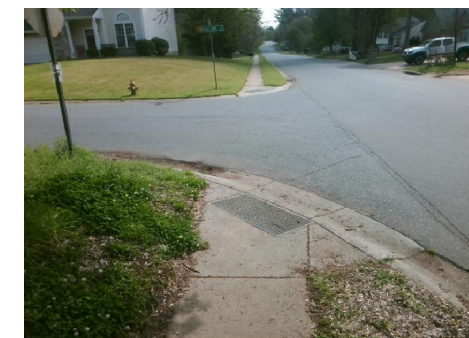
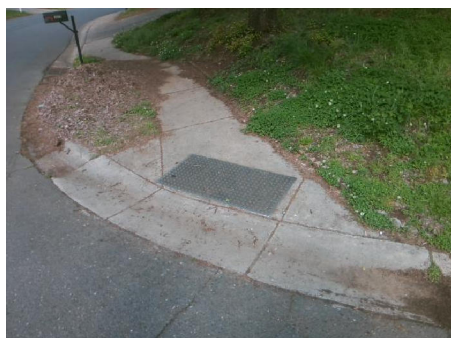
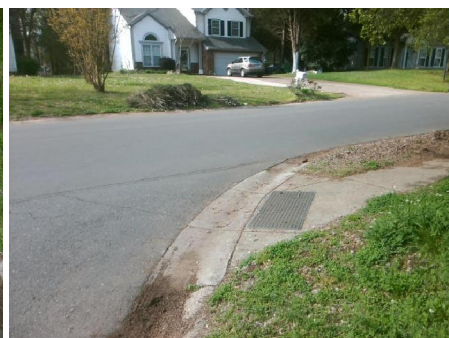
Compliance	Description	Data	Compliance	Description	Data
N/A	Ramp Length (in)	49.0	N/A	Grade Break?	N/A
Yes	Ramp Width (in)	48.0	N/A	Grade Break Slope (%)	0.0
Yes	Ramp Slope (%)	6.9	N/A	Grade Break XSlope (%)	0.0
No	Ramp XSlope (%)	5.9			
N/A	Flare Type LT	N/A	N/A	Flare Type RT	N/A
N/A	Flare Slope LT (%)	N/A	N/A	Flare Slope RT (%)	0.0
N/A	Flare Traversable LT?	N/A	N/A	Flare Traversable RT?	N/A
N/A	Landing Length (in)	0.0	N/A	DWS Provided?	N/A
N/A	Landing Width (in)	0.0	N/A	DWS Contrast?	N/A
N/A	Landing Slope (%)	0.0	N/A	DWS Length (in)	N/A
N/A	Landing X Slope (%)	0.0	N/A	DWS Full Width?	N/A
N/A	Landing Curb? (Y/N)	N/A	N/A	DWS Offset LT (in)	N/A
N/A	Shared Landing?	N/A	N/A	DWS Offset RT (in)	N/A
N/A	Gutter Ponding?	0.0	N/A	Gutter Slope (%)	N/A
N/A	Gutter Lip Ht (in)	0.0	N/A	Gutter X Slope (%)	N/A
N/A	Painted X Walk1?	No		Road Slope (%)	0.5
	X Walk 1 Direction	To NE		Road X Slope (%)	2.2
	X Walk 1 Width (in)	N/A		Clear Space?	N/A

X Walk 1 Slope (%)	0.5	N/A	Clear Space to XWalk (in)	N/A
	X Walk 1 X Slope (%)	2.2	N/A	Storm Grate/Utility Hazard?	N/A
N/A	Ramp inside XWalk1?	N/A		Storm Grate/Utility Type	
N/A	Any Obstructions?	N/A			N/A
	Obstruction Type		Yes	Surface Condition? (G/P)	Good
			N/A	Curb Slope (%)	8.1

Possible Solutions:

Remove & Replace Entire Ramp.

PROW/ADA:

R304.5.3
