# Access Compliance Report

## Public Rights-of-Way

### (Curb Ramps)

Intersection ID: 13806	Main Street: S_TRYON_ST	Cross Street: WEST_BV	Location: E
ADA ID: FAB0E42B1CA7	Ramp Type: Perp	Initial Pass/Fail: Fail	Overall Compliance: No
Severity Score: 13.75			
Codes/Mitigation Info/Possible Solution		Field Measurements/Component Compliance

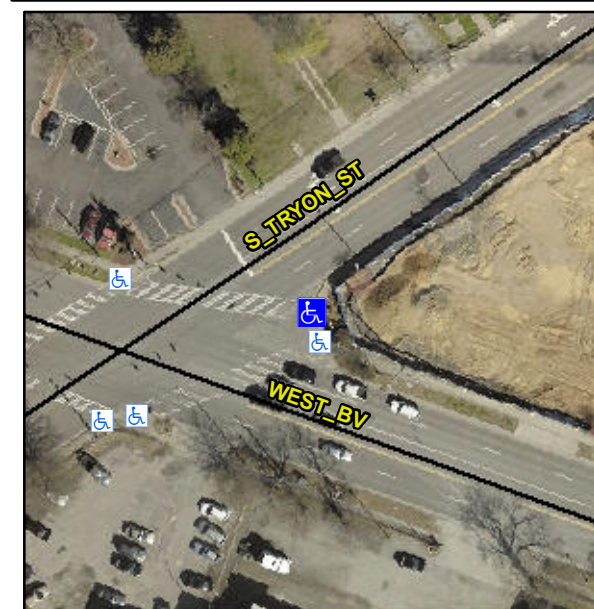
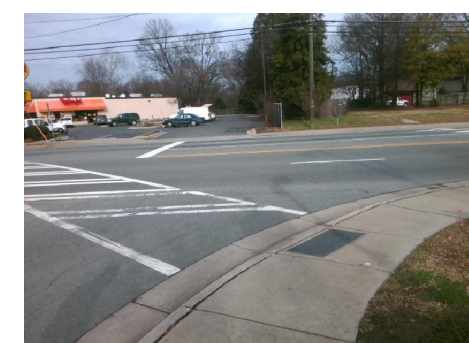
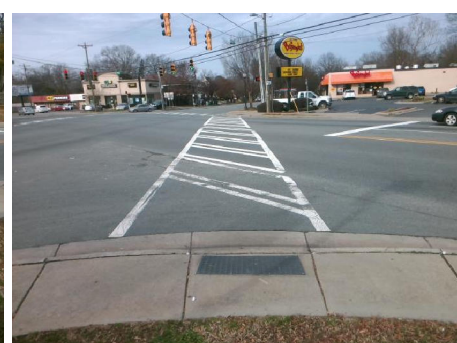
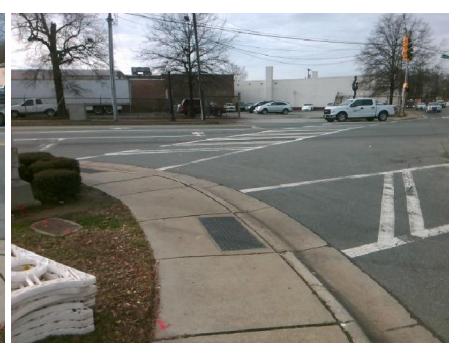
**Not Found, R304.2.2, R304.5.3**

Compliance	Description	Data	Compliance	Description	Data
N/A	Ramp Length (in)	60.0	No	Ramp Slope (%)	9.9
Yes	Ramp Width (in)	48.0	No	Ramp XSlope (%)	4.1
N/A	Flare Type LT	N/A	N/A	Flare Type RT	N/A
N/A	Flare Slope LT (%)	N/A	N/A	Flare Slope RT (%)	N/A
N/A	Flare Traversable LT?	N/A	N/A	Flare Traversable RT?	N/A
N/A	Landing Length (in)	N/A	N/A	DWS Provided?	N/A
N/A	Landing Width (in)	N/A	N/A	DWS Contrast?	N/A
N/A	Landing Slope (%)	N/A	N/A	DWS Length (in)	N/A
N/A	Landing X Slope (%)	N/A	N/A	DWS Full Width?	N/A
N/A	Landing Curb? (Y/N)	N/A	N/A	DWS Offset (in)	N/A
N/A	Shared Landing?	N/A			
N/A	Gutter Ponding?	N/A	N/A	Gutter Slope (%)	N/A
N/A	Gutter Lip Ht (in)	N/A	N/A	Gutter X Slope (%)	N/A
N/A	Painted X Walk1?	Yes	N/A	Painted X Walk2?	N/A
	X Walk 1 Direction	To NW		X Walk 2 Direction	N/A
N/A	X Walk 1 Width (in)	112.0	N/A	X Walk 2 Width (in)	N/A
	X Walk 1 Slope (%)	0.9		X Walk 2 Slope (%)	N/A
	X Walk 1 X Slope (%)	2.1		X Walk 2 X Slope (%)	N/A

N/A	Ramp inside XWalk1?	Yes	N/A	Ramp inside XWalk2?	N/A
	Road Slope (%)	N/A	N/A	Clear Space?	N/A
	Road X Slope (%)	N/A	N/A	Clear Space to XWalk (in)	N/A
N/A	Any Obstructions?	N/A	N/A	Storm Grate/Utility Hazard?	N/A
	Obstruction Type			Storm Grate/Utility Type	
		N/A			N/A
		Yes		Surface Condition? (G/P)	Good

**Remove & Replace Entire Ramp.**

Total Cost: \$ 1850.00
