# Access Compliance Report

## Public Rights-of-Way

### (Curb Ramps)

Intersection ID: 10034320	Main Street: PERIMETER_PY	Cross Street: N/A	Location: W
ADA ID: FAB1ED0D624D	Ramp Type: Perp	Initial Pass/Fail: Fail	Overall Compliance: No
Severity Score: 10			
Codes/Mitigation Info/Possible Solution		Field Measurements/Component Compliance

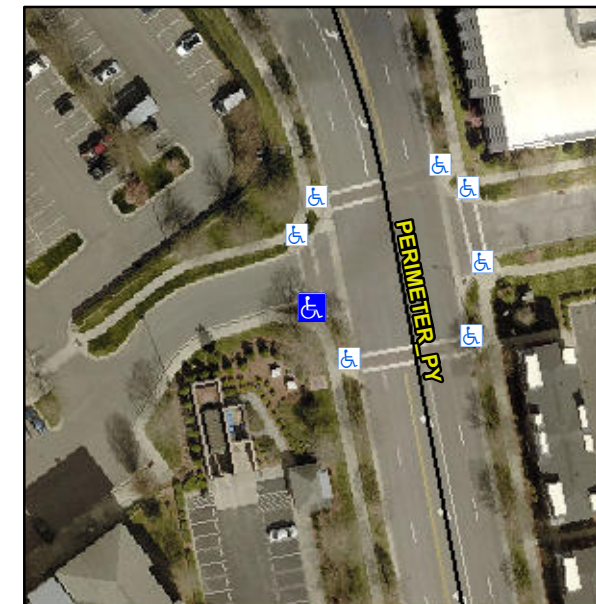
**Not Found, R304.5.1, R304.5.3**

Compliance	Description	Data	Compliance	Description	Data
N/A	Ramp Length (in)	56.0	Yes	Ramp Slope (%)	6.1
No	Ramp Width (in)	47.5	No	Ramp XSlope (%)	4.2
N/A	Flare Type LT	N/A	N/A	Flare Type RT	N/A
N/A	Flare Slope LT (%)	N/A	N/A	Flare Slope RT (%)	N/A
N/A	Flare Traversable LT?	N/A	N/A	Flare Traversable RT?	N/A
N/A	Landing Length (in)	N/A	N/A	DWS Provided?	N/A
N/A	Landing Width (in)	N/A	N/A	DWS Contrast?	N/A
N/A	Landing Slope (%)	N/A	N/A	DWS Length (in)	N/A
N/A	Landing X Slope (%)	N/A	N/A	DWS Full Width?	N/A
N/A	Landing Curb? (Y/N)	N/A	N/A	DWS Offset (in)	N/A
N/A	Shared Landing?	N/A			
N/A	Gutter Ponding?	N/A	N/A	Gutter Slope (%)	N/A
N/A	Gutter Lip Ht (in)	N/A	N/A	Gutter X Slope (%)	N/A
N/A	Painted X Walk1?	Yes	N/A	Painted X Walk2?	N/A
	X Walk 1 Direction	To NE		X Walk 2 Direction	N/A
N/A	X Walk 1 Width (in)	72.0	N/A	X Walk 2 Width (in)	N/A
	X Walk 1 Slope (%)	3.3		X Walk 2 Slope (%)	N/A
	X Walk 1 X Slope (%)	1.8		X Walk 2 X Slope (%)	N/A

N/A	Ramp inside XWalk1?	Yes	N/A	Ramp inside XWalk2?	N/A
	Road Slope (%)	N/A	N/A	Clear Space?	N/A
	Road X Slope (%)	N/A	N/A	Clear Space to XWalk (in)	N/A
N/A	Any Obstructions?	N/A	N/A	Storm Grate/Utility Hazard?	N/A
	Obstruction Type			Storm Grate/Utility Type	
		N/A			N/A
		Yes		Surface Condition? (G/P)	Good

**Remove & Replace Entire Ramp.**
