# Access Compliance Report

## Public Rights-of-Way

### (Curb Ramps)

Intersection ID: 22786	Main Street: INDIAN_HILLS_LN	Cross Street: PECAN_MEADOW_CT	Location: SW
ADA ID: FAC5767D8F0B	Ramp Type: Directional1	Initial Pass/Fail: Fail	Overall Compliance: No
		Severity Score: 10

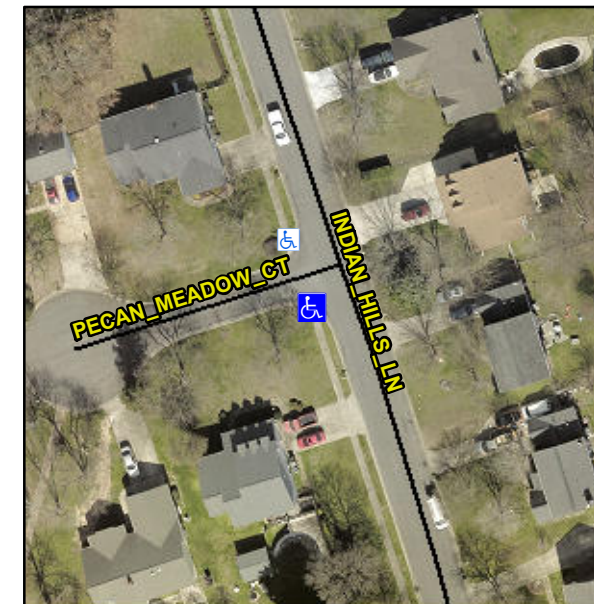
Compliance	Description	Data	Compliance	Description	Data
N/A	Ramp Length (in)	46.5	N/A	Grade Break?	N/A
No	Ramp Width (in)	37.0	N/A	Grade Break Slope (%)	0.0
Yes	Ramp Slope (%)	6.3	N/A	Grade Break XSlope (%)	0.0
No	Ramp XSlope (%)	3.2			
N/A	Flare Type LT	N/A	N/A	Flare Type RT	N/A
N/A	Flare Slope LT (%)	N/A	N/A	Flare Slope RT (%)	0.0
N/A	Flare Traversable LT?	N/A	N/A	Flare Traversable RT?	N/A
N/A	Landing Length (in)	0.0	N/A	DWS Provided?	N/A
N/A	Landing Width (in)	0.0	N/A	DWS Contrast?	N/A
N/A	Landing Slope (%)	0.0	N/A	DWS Length (in)	N/A
N/A	Landing X Slope (%)	0.0	N/A	DWS Full Width?	N/A
N/A	Landing Curb? (Y/N)	N/A	N/A	DWS Offset LT (in)	N/A
N/A	Shared Landing?	N/A	N/A	DWS Offset RT (in)	N/A
N/A	Gutter Ponding?	0.0	N/A	Gutter Slope (%)	N/A
N/A	Gutter Lip Ht (in)	0.0	N/A	Gutter X Slope (%)	N/A
N/A	Painted X Walk1?	No		Road Slope (%)	3.0
	X Walk 1 Direction	To NW		Road X Slope (%)	1.4
	X Walk 1 Width (in)	N/A		Clear Space?	N/A

X Walk 1 Slope (%)	3.0	N/A	Clear Space to XWalk (in)	N/A
	X Walk 1 X Slope (%)	1.4	N/A	Storm Grate/Utility Hazard?	N/A
N/A	Ramp inside XWalk1?	N/A		Storm Grate/Utility Type	
N/A	Any Obstructions?	N/A			N/A
	Obstruction Type		Yes	Surface Condition? (G/P)	Good
			N/A	Curb Slope (%)	12.8

**Remove & Replace Entire Ramp.**
