Access Compliance Report

Public Rights-of-Way

(Curb Ramps)

Intersection ID: N/A	Main Street: TREMONT_ST	Cross Street: N/A	Location: NE
ADA ID: FAD6BE60A17F	Ramp Type: Perp	Initial Pass/Fail: Fail	Overall Compliance: No
Codes/Mitigation Info/Possible Solution		Field Measurements/Component Compliance	
Severity Score: 12.5

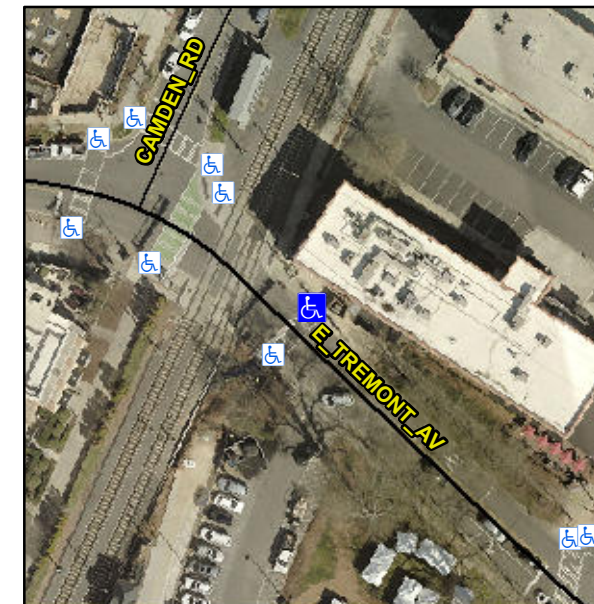
Not Found, R304.2.2

Compliance	Description	Data	Compliance	Description	Data
N/A	Ramp Length (in)	66.5	No	Ramp Slope (%)	11.6
Yes	Ramp Width (in)	49.0	Yes	Ramp XSlope (%)	1.3
N/A	Flare Type LT	N/A	N/A	Flare Type RT	N/A
N/A	Flare Slope LT (%)	N/A	N/A	Flare Slope RT (%)	N/A
N/A	Flare Traversable LT?	N/A	N/A	Flare Traversable RT?	N/A
N/A	Landing Length (in)	N/A	N/A	DWS Provided?	N/A
N/A	Landing Width (in)	N/A	N/A	DWS Contrast?	N/A
N/A	Landing Slope (%)	N/A	N/A	DWS Length (in)	N/A
N/A	Landing X Slope (%)	N/A	N/A	DWS Full Width?	N/A
N/A	Landing Curb? (Y/N)	N/A	N/A	DWS Offset (in)	N/A
N/A	Shared Landing?	N/A			
N/A	Gutter Ponding?	N/A	N/A	Gutter Slope (%)	N/A
N/A	Gutter Lip Ht (in)	N/A	N/A	Gutter X Slope (%)	N/A
N/A	Painted X Walk1?	Yes	N/A	Painted X Walk2?	N/A
	X Walk 1 Direction	To SW		X Walk 2 Direction	N/A
N/A	X Walk 1 Width (in)	109.0	N/A	X Walk 2 Width (in)	N/A
	X Walk 1 Slope (%)	0.1		X Walk 2 Slope (%)	N/A
	X Walk 1 X Slope (%)	0.1		X Walk 2 X Slope (%)	N/A

N/A	Ramp inside XWalk1?	Yes	N/A	Ramp inside XWalk2?	N/A
	Road Slope (%)	N/A	N/A	Clear Space?	N/A
	Road X Slope (%)	N/A	N/A	Clear Space to XWalk (in)	N/A
N/A	Any Obstructions?	N/A	N/A	Storm Grate/Utility Hazard?	N/A
	Obstruction Type			Storm Grate/Utility Type	
		N/A			N/A
			Yes	Surface Condition? (G/P)	Good

Possible Solutions:

Remove & Replace Entire Ramp.
