# Access Compliance Report

## Public Rights-of-Way

### (Curb Ramps)

Intersection ID: 29245	Main Street: CAYMUS_DR	Cross Street: MALLARD_FOREST_DR	Location: SW
ADA ID: FAD72BFFA193	Ramp Type: BlendTrans1	Initial Pass/Fail: Fail	Overall Compliance: No
		Severity Score: 8.75

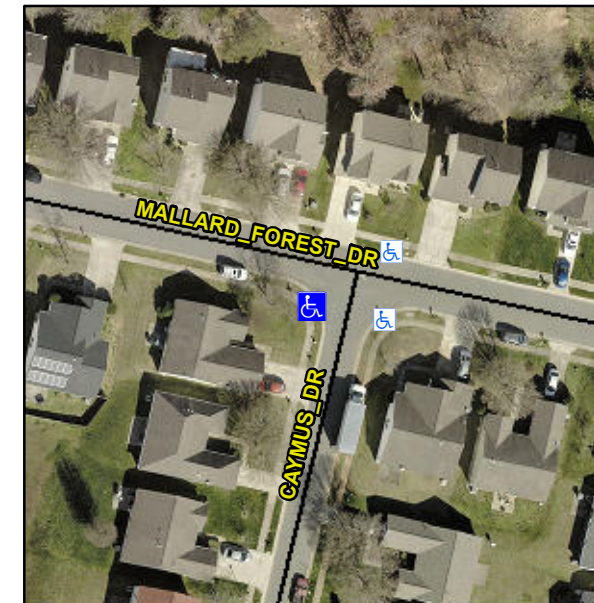
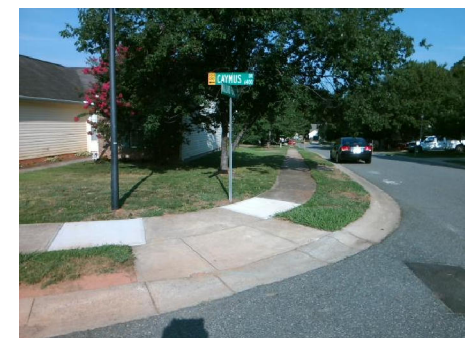
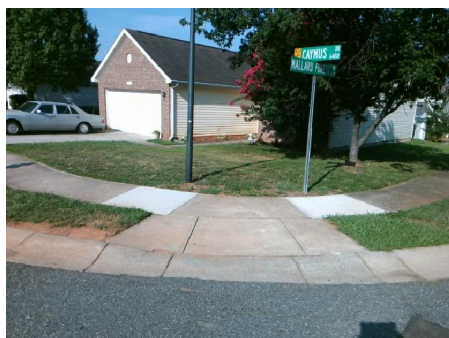
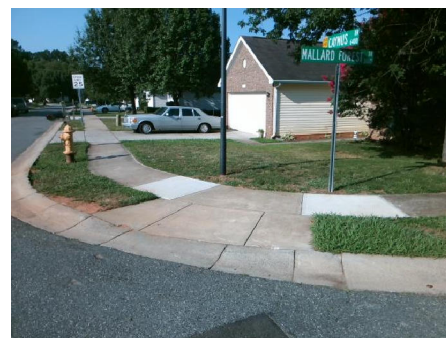
**Not Found, R304.5.1**

Compliance	Description	Data	Compliance	Description	Data
N/A	Ramp Length (in)	48.0	Yes	BlendTrans Slope (%)	3.1
No	Ramp Width (in)	47.0	Yes	BlendTrans XSlope (%)	1.9
N/A	Flare Type LT	N/A	N/A	Flare Type RT	N/A
N/A	Flare Slope LT (%)	N/A	N/A	Flare Slope RT (%)	N/A
N/A	Flare Traversable LT?	N/A	N/A	Flare Traversable RT?	N/A
N/A	Landing Length (in)	N/A	N/A	DWS Provided?	N/A
N/A	Landing Width (in)	N/A	N/A	DWS Contrast?	N/A
N/A	Landing Slope (%)	N/A	N/A	DWS Length (in)	N/A
N/A	Landing X Slope (%)	N/A	N/A	DWS Full Width?	N/A
N/A	Landing Curb? (Y/N)	N/A	N/A	DWS Offset (in)	N/A
N/A	Shared Landing?	N/A			
N/A	Gutter Ponding?	N/A	N/A	Gutter Slope (%)	N/A
N/A	Gutter Lip Ht (in)	0.5	N/A	Gutter X Slope (%)	N/A
N/A	Painted X Walk1?	No	N/A	Painted X Walk2?	No
	X Walk 1 Direction	To E		X Walk 2 Direction	To N
	X Walk 1 Width (in)	N/A		X Walk 2 Width (in)	N/A
	X Walk 1 Slope (%)	3.8		X Walk 2 Slope (%)	4.2
	X Walk 1 X Slope (%)	2.0		X Walk 2 X Slope (%)	0.3

N/A	Ramp inside XWalk1?	N/A	N/A	Ramp inside XWalk2?	N/A
	Road Slope (%)	1.0		Clear Space?	N/A
	Road X Slope (%)	1.3	N/A	Clear Space to XWalk (in)	N/A
N/A	Any Obstructions?	N/A	N/A	Storm Grate/Utility Hazard?	N/A
	Obstruction Type			Storm Grate/Utility Type	
		N/A			N/A
			Yes	Surface Condition? (G/P)	Good
			No	Curb Slope (%)	11.7

**Remove & Replace Curb Ramp With Two New Directional Ramps or Equivalent.**
