## Access Compliance Report Public Rights-of-Way (Curb Ramps)

Intersection ID: 20241	0241 Main Street: ANN_MARIE_DR			treet:	NATIONS_FORD_RD	Location:	SW		
ADA ID: FAD90FFED669	669 Ramp Type: PerpDiag			Initial Pass/Fail: Fail Overall Compliance: No				o Severity Score:	8.75
Codes/Mitigation Info/Possible Solution				Field Measurements/Component Compliance					
	6	Possible Solutions:		Compliance Description Data Com			Comp	liance Description	Data
		Remove & Replace Curb Ramp W	/ith	N/A	Ramp Length (in)	44.0	Yes	Ramp Slope (%)	7.6
		Two New Directional Ramps or		No	Ramp Width (in)	43.0	Yes	Ramp XSlope (%)	0.5
		Equivalent.		N/A	Flare Type LT	N/A	N/A	Flare Type RT	N/A
				N/A	Flare Slope LT (%)	N/A	N/A	Flare Slope RT (%)	N/A
				N/A	Flare Traversable LT?	N/A	N/A	Flare Traversable RT?	N/A
the second se				N/A	Landing Length (in)	N/A	N/A	DWS Provided?	N/A
CHOYCE AV		Surveyor Notes:		N/A	Landing Width (in)	N/A	N/A	DWS Contrast?	N/A
the second secon		N/A		N/A	Landing Slope (%)	N/A	N/A	DWS Length (in)	N/A

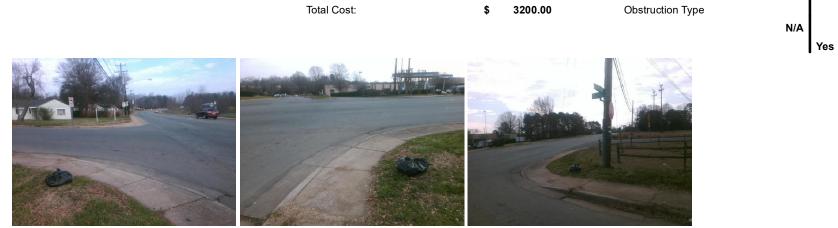
N/A	Landing X Slope (%)	N/A	N/A	DWS Full Width?	N/A
and the second	L. 13			N/A	Landing Curb? (Y/N)	N/A	N/A	DWS Offset (in)	N/A
Surgeringer an and and			N/A	Shared Landing?	N/A				
De la companya de la comp	St b	PROW/ADA:		N/A	Gutter Ponding?	N/A	N/A	Gutter Slope (%)	N/A
States and States		Not Found, R304.5.1		N/A	Gutter Lip Ht (in)	N/A	N/A	Gutter X Slope (%)	N/A
and the second s	ETA 1 3	, , , , , , , , , , , , , , , , , , ,		N/A	Painted X Walk1?	No	N/A	Painted X Walk2?	No
					X Walk 1 Direction	To E		X Walk 2 Direction	To N
				N/A	X Walk 1 Width (in)	N/A	N/A	X Walk 2 Width (in)	N/A
Street 1 Name	NATIONS FORD RD				X Walk 1 Slope (%)	2.2		X Walk 2 Slope (%)	4.0
Stop Condition-Street 2	None				X Walk 1 X Slope (%)	2.7		X Walk 2 X Slope (%)	2.1
Street 2 Name	CHOYCE AV			N/A	Ramp inside XWalk1?	N/A	N/A	Ramp inside XWalk2?	N/A
Stop Condition-Street 1	StopSign				Road Slope (%)	0.9	N/A	Clear Space?	N/A

Road X Slope (%)	2.5	N/A	Clear Space to XWalk (in)	N/A
				N/A	Any Obstructions?	N/A	N/A	Storm Grate/Utility Hazard?	N/A
		Total Cost: \$ 32	200.00		Obstruction Type			Storm Grate/Utility Type	
						N/A			N/A
4							1
