Access Compliance Report

Public Rights-of-Way

(Curb Ramps)

| Intersection ID: 29956 | Main Street: NEW_HOUSE_DR | Cross Street: ROYAL_BLUFF_DR | Location: SW |

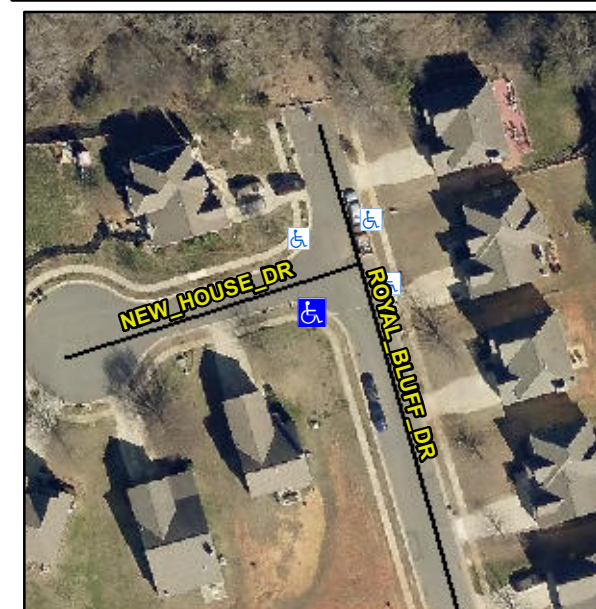
| ADA ID: FAE17CD82190 | Ramp Type: PerpDiag | Initial Pass/Fail: Fail | Overall Compliance: No |
| Severity Score: 10 | | | |

R304.5.1, R304.5.3

| Compliance | Description | Data | Compliance | Description | Data |
|---|---|---|---|---|---|
| N/A | Ramp Length (in) | 48.0 | Yes | Ramp Slope (%) | 6.1 |
| No | Ramp Width (in) | 47.0 | No | Ramp XSlope (%) | 4.2 |

Remove & Replace Curb Ramp With Two New Directional Ramps or Equivalent.
