## Access Compliance Report Public Rights-of-Way (Curb Ramps)

Intersection ID: 7898Main Street:N\_HOSKINS\_RDCross Street:TENNESSEE\_AVLocation:NEADA ID: FAE4C12086E8Ramp Type:BlendTrans2Initial Pass/Fail:FailOverall Compliance:NoSeverity Score:25

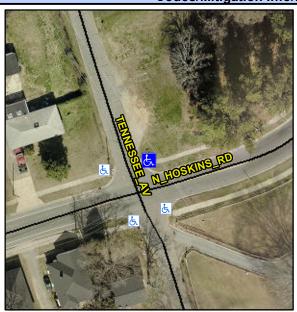
Not Found, R304.5.3

| Compliance Description | | Data | Comp | liance Description | Data |
|---|---|---|---|---|---|
| Yes | Ramp Width (in) | 69.0 | No | BlendTrans XSlope (%) | 7.0 |
| | | | No | Curb Slope (%) | 13.3 |

Remove & Replace Curb Ramp With Two New Directional Ramps or Equivalent.

Total Cost: \$ 3200.00
