Access Compliance Report

Public Rights-of-Way

(Curb Ramps)

Intersection ID: 16844	Main Street: DICKINSON_PL	Cross Street: HASTINGS_DR	Location: NE
ADA ID: FAEA5A543992	Ramp Type: Perp	Initial Pass/Fail: Fail	Overall Compliance: No
			Severity Score: 26.25

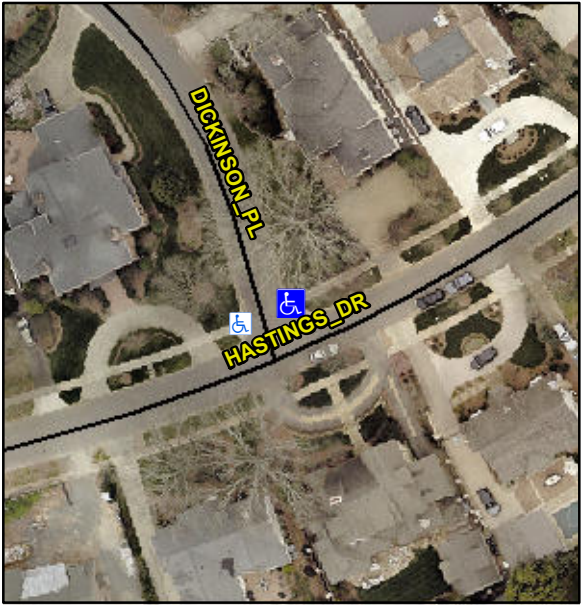
<p>Street 1 Name DICKINSON PL</p> <p>Stop Condition-Street 2 StopSign</p> <p>Street 2 Name N/A</p> <p>Stop Condition-Street 1 N/A</p>	Possible Solutions:	Remove & Replace Entire Ramp.					
	Surveyor Notes:	N/A					
	PROW/ADA:	Not Found, R304.5.3					
			Compliance	Description	Data	Compliance	Description
			N/A	Ramp Length (in)	232.0	Yes	Ramp Slope (%)
			Yes	Ramp Width (in)	53.5	No	Ramp XSlope (%)
			N/A	Flare Type LT	N/A	N/A	Flare Type RT
			N/A	Flare Slope LT (%)	N/A	N/A	Flare Slope RT (%)
			N/A	Flare Traversable LT?	N/A	N/A	Flare Traversable RT?
			N/A	Landing Length (in)	N/A	N/A	DWS Provided?
			N/A	Landing Width (in)	N/A	N/A	DWS Contrast?
			N/A	Landing Slope (%)	N/A	N/A	DWS Length (in)
			N/A	Landing X Slope (%)	N/A	N/A	DWS Full Width?
			N/A	Landing Curb? (Y/N)	N/A	N/A	DWS Offset (in)
			N/A	Shared Landing?	N/A

N/A	Gutter Ponding?	N/A	N/A	Gutter Slope (%)
			N/A	Gutter Lip Ht (in)	N/A	N/A	Gutter X Slope (%)
			N/A	Painted X Walk1?	No	N/A	Painted X Walk2?
				X Walk 1 Direction	To W		X Walk 2 Direction
			N/A	X Walk 1 Width (in)	N/A	N/A	X Walk 2 Width (in)
				X Walk 1 Slope (%)	4.4		X Walk 2 Slope (%)
				X Walk 1 X Slope (%)	7.2		X Walk 2 X Slope (%)
			N/A	Ramp inside XWalk1?	N/A	N/A	Ramp inside XWalk2?
				Road Slope (%)	N/A	N/A	Clear Space?
				Road X Slope (%)	N/A	N/A	Clear Space to XWalk (in)
			N/A	Any Obstructions?	N/A	N/A	Storm Grate/Utility Hazard?
				Obstruction Type			Storm Grate/Utility Type
					N/A		N/A
						Yes	Surface Condition? (G/P)
							Good
