# Access Compliance Report

## Public Rights-of-Way

### (Curb Ramps)

| Intersection ID: 2877 | Main Street: GOLDENFIELD_DR | Cross Street: FOGGY_MEADOW_RD | Location: SE |

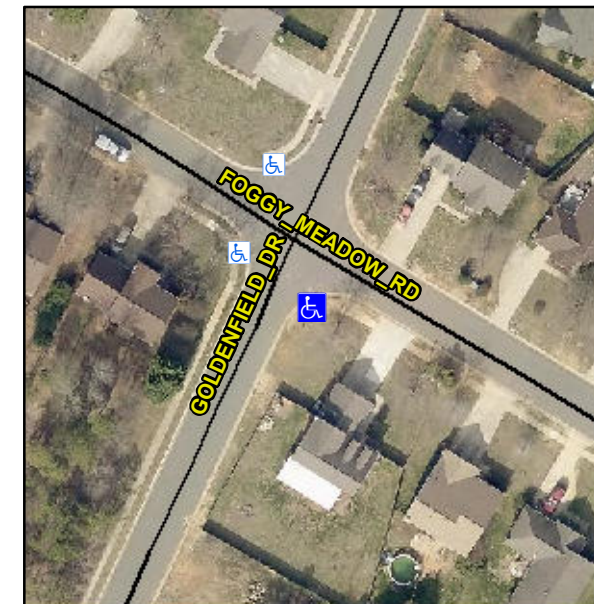
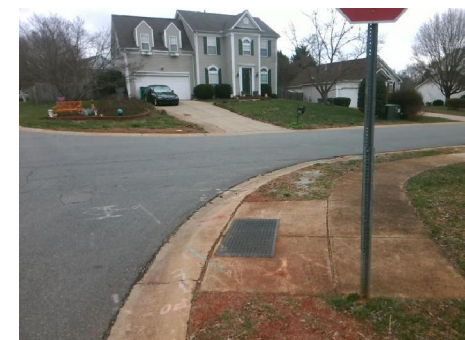
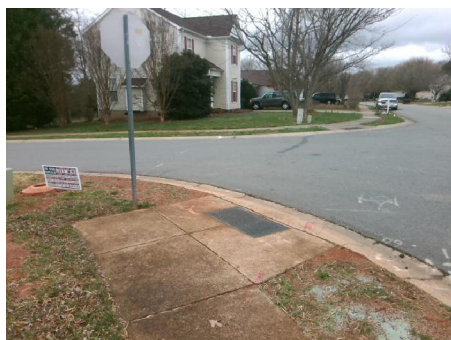
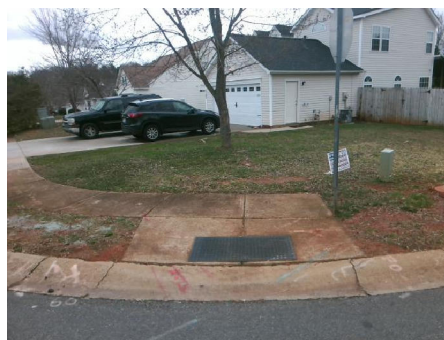
| ADA ID: FAEFEA2C029A | Ramp Type: BlendTrans2 | Initial Pass/Fail: Pass | Overall Compliance: No |

| Severity Score: 7.5 | | | |

**Not Found, R305.2, R302.7.2**

| Compliance | Description | Data | Compliance | Description | Data |
|---|---|---|---|---|---|
| N/A | Landing Curb? (Y/N) | No | No | DWS Offset (in) | 2.5 |
| No | Gutter Lip Ht (in) | 0.3 | Yes | Gutter X Slope (%) | 0.1 |
| | | | No | Curb Slope (%) | 16.6 |

**Remove & Replace Curb Ramp With Two New Directional Ramps or Equivalent.**

Total Cost: \$ 3200.00
