Access Compliance Report

Public Rights-of-Way

(Curb Ramps)

Intersection ID: 13854	Main Street: E_PARK_AV	Cross Street: SOUTH_BV	Location: NW
ADA ID: FB0129760843	Ramp Type: BlendTrans2	Initial Pass/Fail: Fail	Overall Compliance: No
Codes/Mitigation Info/Possible Solution		Field Measurements/Component Compliance	
Severity Score: 18.75

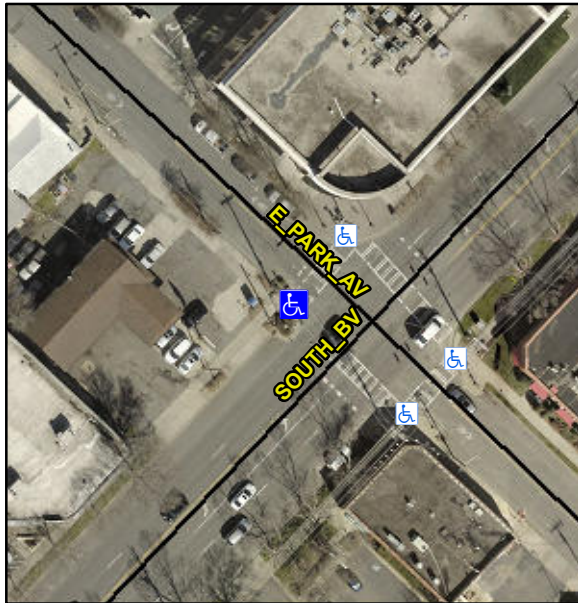
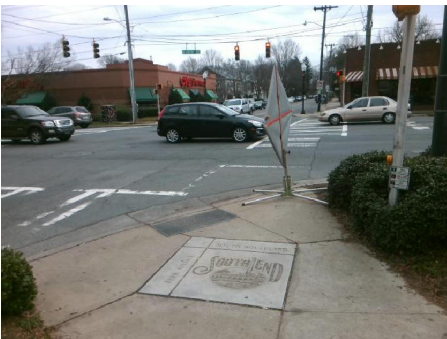
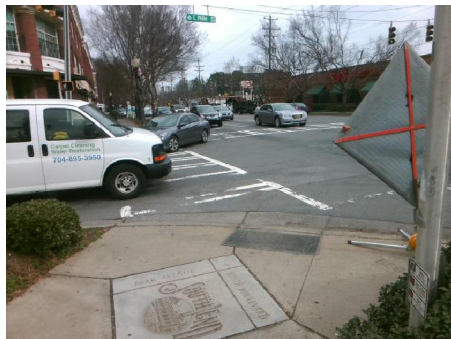
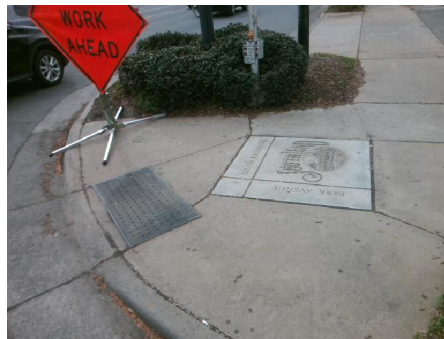
Compliance	Description	Data	Compliance	Description	Data
N/A	Ramp Length (in)	36.0	Yes	BlendTrans Slope (%)	1.0
No	Ramp Width (in)	35.0	No	BlendTrans XSlope (%)	2.6
N/A	Flare Type LT	N/A	N/A	Flare Type RT	N/A
N/A	Flare Slope LT (%)	N/A	N/A	Flare Slope RT (%)	N/A
N/A	Flare Traversable LT?	N/A	N/A	Flare Traversable RT?	N/A
N/A	Landing Length (in)	N/A	N/A	DWS Provided?	N/A
N/A	Landing Width (in)	N/A	N/A	DWS Contrast?	N/A
N/A	Landing Slope (%)	N/A	N/A	DWS Length (in)	N/A
N/A	Landing X Slope (%)	N/A	N/A	DWS Full Width?	N/A
N/A	Landing Curb? (Y/N)	N/A	N/A	DWS Offset (in)	N/A
N/A	Shared Landing?	N/A			
N/A	Gutter Ponding?	N/A	N/A	Gutter Slope (%)	N/A
N/A	Gutter Lip Ht (in)	N/A	N/A	Gutter X Slope (%)	N/A
N/A	Painted X Walk1?	No	N/A	Painted X Walk2?	Yes
	X Walk 1 Direction	To SE		X Walk 2 Direction	To NE
	X Walk 1 Width (in)	N/A		X Walk 2 Width (in)	111.0
	X Walk 1 Slope (%)	6.1		X Walk 2 Slope (%)	0.2
	X Walk 1 X Slope (%)	0.3		X Walk 2 X Slope (%)	4.3

N/A	Ramp inside XWalk1?	N/A	N/A	Ramp inside XWalk2?	Yes
	Road Slope (%)	2.0		Clear Space?	N/A
	Road X Slope (%)	3.8	N/A	Clear Space to XWalk (in)	N/A
N/A	Any Obstructions?	N/A	N/A	Storm Grate/Utility Hazard?	N/A
	Obstruction Type			Storm Grate/Utility Type	
		N/A			N/A
			Yes	Surface Condition? (G/P)	Good
			N/A	Curb Slope (%)	2.3

Remove & Replace Curb Ramp With Two New Directional Ramps or Equivalent.
