Access Compliance Report

Public Rights-of-Way

(Curb Ramps)

Intersection ID: 48767	Main Street: TURNING_WHEEL_DR	Cross Street: MINITREE_LN	Location: SE
ADA ID: FB02B499B172	Ramp Type: PerpDiag	Initial Pass/Fail: Fail	Overall Compliance: No
Severity Score: 12.5			
Codes/Mitigation Info/Possible Solution		Field Measurements/Component Compliance

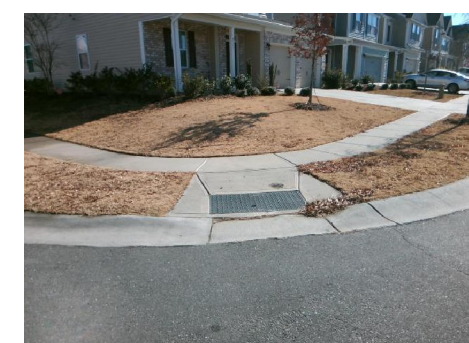
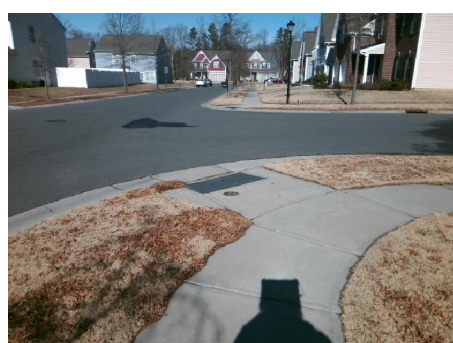
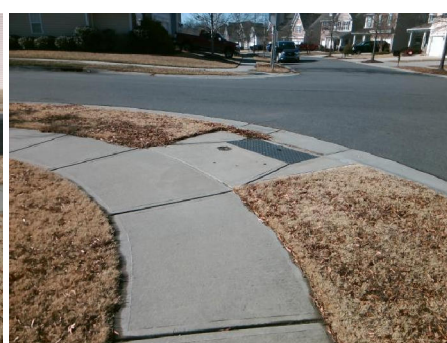
Compliance	Description	Data	Compliance	Description	Data
N/A	Ramp Length (in)	71.0	No	Ramp Slope (%)	9.5
Yes	Ramp Width (in)	48.0	Yes	Ramp XSlope (%)	0.2
N/A	Flare Type LT	N/A	N/A	Flare Type RT	N/A
N/A	Flare Slope LT (%)	N/A	N/A	Flare Slope RT (%)	N/A
N/A	Flare Traversable LT?	N/A	N/A	Flare Traversable RT?	N/A
N/A	Landing Length (in)	N/A	N/A	DWS Provided?	N/A
N/A	Landing Width (in)	N/A	N/A	DWS Contrast?	N/A
N/A	Landing Slope (%)	N/A	N/A	DWS Length (in)	N/A
N/A	Landing X Slope (%)	N/A	N/A	DWS Full Width?	N/A
N/A	Landing Curb? (Y/N)	N/A	N/A	DWS Offset (in)	N/A
N/A	Shared Landing?	N/A			
N/A	Gutter Ponding?	N/A	N/A	Gutter Slope (%)	N/A
N/A	Gutter Lip Ht (in)	N/A	N/A	Gutter X Slope (%)	N/A
N/A	Painted X Walk1?	No	N/A	Painted X Walk2?	No
	X Walk 1 Direction	To N		X Walk 2 Direction	To W
N/A	X Walk 1 Width (in)	N/A	N/A	X Walk 2 Width (in)	N/A
	X Walk 1 Slope (%)	0.1		X Walk 2 Slope (%)	0.0
	X Walk 1 X Slope (%)	1.2		X Walk 2 X Slope (%)	0.8

N/A	Ramp inside XWalk1?	N/A	N/A	Ramp inside XWalk2?	N/A
	Road Slope (%)	2.2	N/A	Clear Space?	N/A
	Road X Slope (%)	0.0	N/A	Clear Space to XWalk (in)	N/A
N/A	Any Obstructions?	N/A	N/A	Storm Grate/Utility Hazard?	N/A
	Obstruction Type			Storm Grate/Utility Type	
		N/A			N/A
			Yes	Surface Condition? (G/P)	Good

Possible Solutions:

Remove & Replace Curb Ramp With Two New Directional Ramps or Equivalent.

R304.2.2
