# Access Compliance Report

## Public Rights-of-Way

### (Curb Ramps)

Intersection ID: 12900	Main Street: ARNOLD_DR	Cross Street: DRAPER_AV	Location: SE
ADA ID: FB03806CA696	Ramp Type: Para	Initial Pass/Fail: Fail	Overall Compliance: No
Codes/Mitigation Info/Possible Solution		Field Measurements/Component Compliance	
Severity Score: 33.75

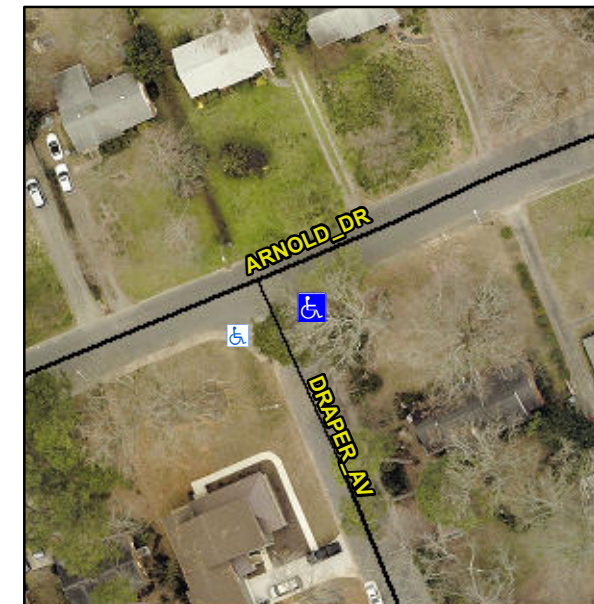
Surveyor Notes:

**LT RP < 5%**

PROW/ADA:

**R304.5.1, R304.3.2**

Possible Solutions:

**Remove & Replace Entire Ramp.**
