Access Compliance Report

Public Rights-of-Way

(Curb Ramps)

Intersection ID: 10033675	Main Street: ORCHARD_LAKE_DR	Cross Street: N/A	Location: NE
ADA ID: FB04C2ECA282	Ramp Type: Perp	Initial Pass/Fail: Pass	Overall Compliance: No
		Severity Score: 17.5

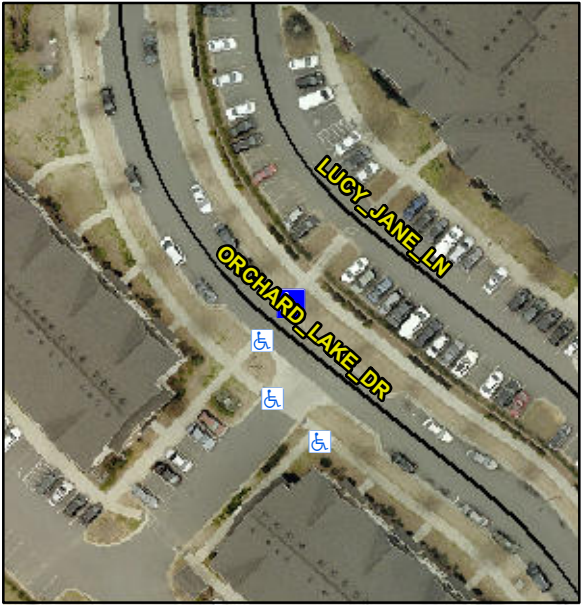
Possible Solutions:		Compliance	Description	Data
	Remove & Replace Entire Ramp.		Yes	Ramp Length (in)	169.0
			Yes	Ramp Width (in)	71.5
			N/A	Flare Type LT	Sloped
			N/A	Flare Slope LT (%)	0.1
			N/A	Flare Traversable LT?	No
			Yes	Landing Length (in)	71.0
			Yes	Landing Width (in)	72.0
			Yes	Landing Slope (%)	0.1
			Yes	Landing X Slope (%)	0.9
<p>Surveyor Notes:</p> <p>N/A</p> <p>PROW/ADA:</p> <p>Not Found, R305.1.4, R302.7.2</p>			N/A	Flare Type RT	N/A
			N/A	Flare Slope RT (%)	6.9
			N/A	Flare Traversable RT?	No
			Yes	DWS Provided?	Yes
			Yes	DWS Contrast?	Yes
			Yes	DWS Length (in)	24.0
			No	DWS Full Width?	No
			Yes	DWS Offset (in)	1.0
			No	Gutter Ponding?	No
			No	Gutter Lip Ht (in)	1.0
			N/A	Painted X Walk1?	No
				X Walk 1 Direction	To SW
			N/A	X Walk 1 Width (in)	N/A
				X Walk 1 Slope (%)	1.2
				X Walk 1 X Slope (%)	0.3

N/A	Ramp inside XWalk1?	N/A
			N/A	Road Slope (%)	N/A
			N/A	Road X Slope (%)	N/A
			Yes	Any Obstructions?	No
				Obstruction Type	
Total Cost: \$ 1850.00			N/A	Storm Grate/Utility Hazard?	No
				Storm Grate/Utility Type	
			N/A		N/A
			Yes	Surface Condition? (G/P)	Good
