# Access Compliance Report

## Public Rights-of-Way

### (Curb Ramps)

Intersection ID: 50598	Main Street: BENDING_BRANCH_RD	Cross Street: BEAR_GRASS_LN	Location:	E
ADA ID: FB07157A82A0	Ramp Type: Perp	Initial Pass/Fail: Fail	Overall Compliance: No	Severity Score: 22.5
Codes/Mitigation Info/Possible Solution		Field Measurements/Component Compliance

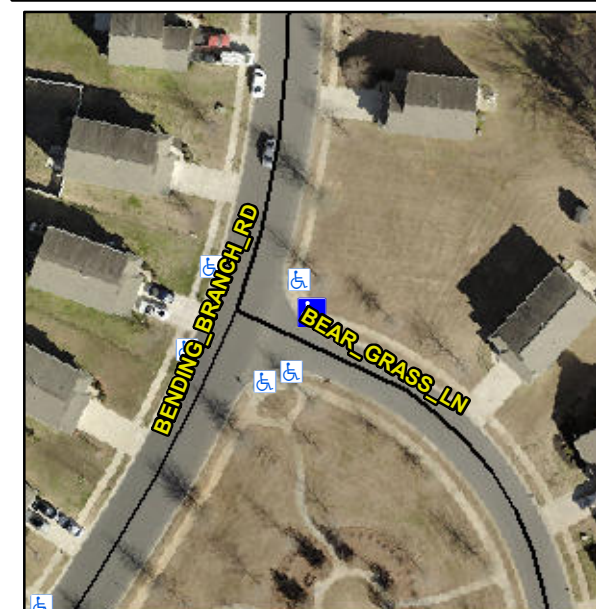
**Not Found, R304.5.1, R304.2.2, R304.5.3**

Compliance	Description	Data	Compliance	Description	Data
N/A	Ramp Length (in)	47.0	No	Ramp Slope (%)	10.8
No	Ramp Width (in)	47.5	No	Ramp XSlope (%)	3.4
N/A	Flare Type LT	N/A	N/A	Flare Type RT	N/A
N/A	Flare Slope LT (%)	N/A	N/A	Flare Slope RT (%)	N/A
N/A	Flare Traversable LT?	N/A	N/A	Flare Traversable RT?	N/A
N/A	Landing Length (in)	N/A	N/A	DWS Provided?	N/A
N/A	Landing Width (in)	N/A	N/A	DWS Contrast?	N/A
N/A	Landing Slope (%)	N/A	N/A	DWS Length (in)	N/A
N/A	Landing X Slope (%)	N/A	N/A	DWS Full Width?	N/A
N/A	Landing Curb? (Y/N)	N/A	N/A	DWS Offset (in)	N/A
N/A	Shared Landing?	N/A			
N/A	Gutter Ponding?	N/A	N/A	Gutter Slope (%)	N/A
N/A	Gutter Lip Ht (in)	N/A	N/A	Gutter X Slope (%)	N/A
N/A	Painted X Walk1?	No	N/A	Painted X Walk2?	N/A
	X Walk 1 Direction	To S		X Walk 2 Direction	N/A
N/A	X Walk 1 Width (in)	N/A	N/A	X Walk 2 Width (in)	N/A
	X Walk 1 Slope (%)	3.2		X Walk 2 Slope (%)	N/A
	X Walk 1 X Slope (%)	2.2		X Walk 2 X Slope (%)	N/A

**Remove & Replace Entire Ramp.**

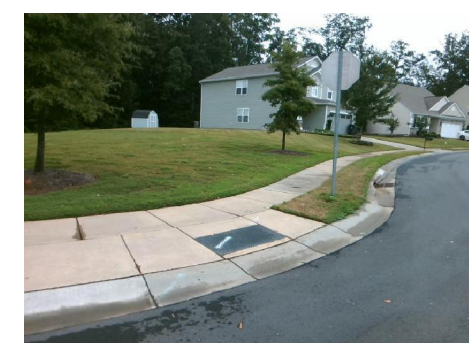
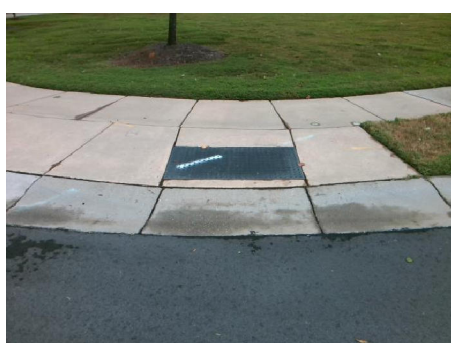
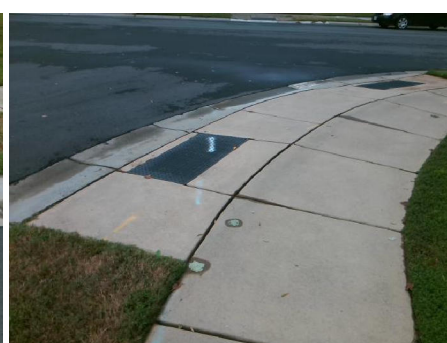
N/A	Ramp inside XWalk1?	N/A	N/A	Ramp inside XWalk2?	N/A
	Road Slope (%)	N/A	N/A	Clear Space?	N/A
	Road X Slope (%)	N/A	N/A	Clear Space to XWalk (in)	N/A
N/A	Any Obstructions?	N/A	N/A	Storm Grate/Utility Hazard?	N/A
	Obstruction Type			Storm Grate/Utility Type	
		N/A			N/A
			Yes	Surface Condition? (G/P)	Good
