# Access Compliance Report

## Public Rights-of-Way

### (Curb Ramps)

| Intersection ID: N/A | Main Street: STONEWALL_ST | Cross Street: JOHN_BELK_RA | Location: S |

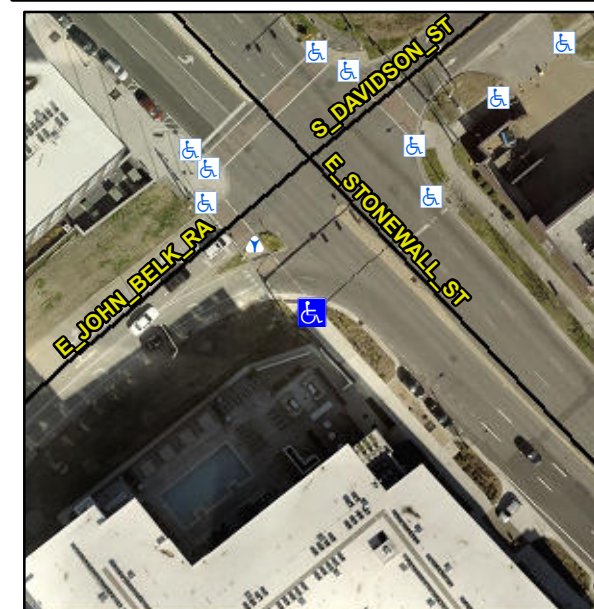
**R304.2.2-Perp, R304.3.2-Para,  
R304.5.3**

| Compliance | Description | Data | Compliance | Description | Data |
|---|---|---|---|---|---|
| Yes | Ramp Width (in) | 118.5 | No | Grade Break Slope (%) | 8.8 |
| Yes | Ramp Slope (%) | 6.8 | No | Grade Break XSlope (%) | 6.3 |
| No | Landing Slope (%) | 2.2 | Yes | DWS Length (in) | 24.0 |
| Yes | Gutter Lip Ht (in) | 0.0 | No | Gutter X Slope (%) | 5.1 |

**Remove & Replace Entire Ramp.  
Remove & Replace Gutter.**
