# Access Compliance Report

## Public Rights-of-Way

### (Curb Ramps)

| ADA ID: FB19AACA8F36 | Ramp Type: Perp | Initial Pass/Fail: Fail | Overall Compliance: No |

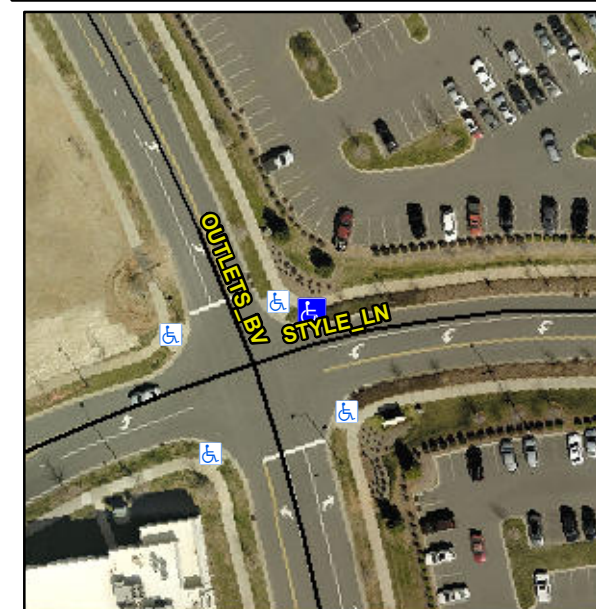
**R304.2.2, R304.5.3**

| Compliance | Description | Data | Compliance | Description | Data |
|---|---|---|---|---|---|
| N/A | Ramp Length (in) | 97.0 | No | Ramp Slope (%) | 9.6 |
| Yes | Ramp Width (in) | 48.0 | No | Ramp XSlope (%) | 4.6 |

**Remove & Replace Entire Ramp.**

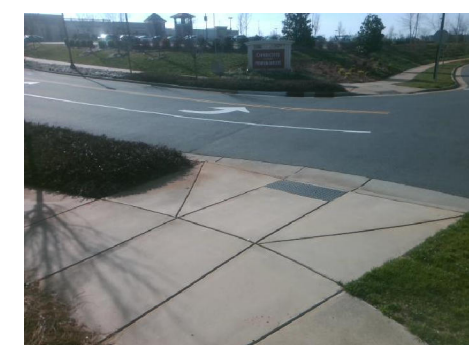
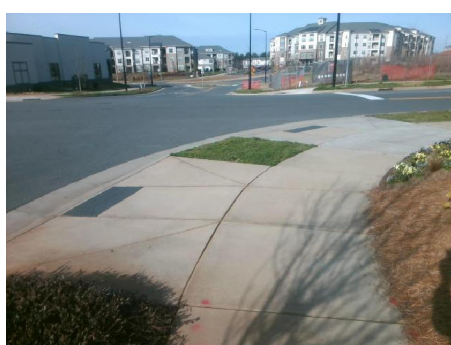
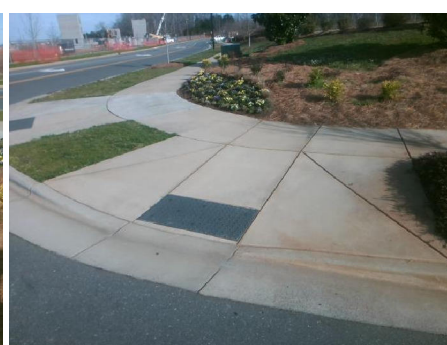
| Compliance | Description | Data | Compliance | Description | Data |
|---|---|---|---|---|---|
| | | Yes | | Surface Condition? (G/P) | Good |
