# Access Compliance Report

## Public Rights-of-Way

### (Curb Ramps)

Intersection ID: 25441	Main Street: PROVIDENCE PLANTATION LN	Cross Street: PROVIDENCE SPRING LN	Location: E
ADA ID: FB1EC1B34388	Ramp Type: Perp	Initial Pass/Fail: Fail	Overall Compliance: No
Severity Score: 25			
Codes/Mitigation Info/Possible Solution		Field Measurements/Component Compliance

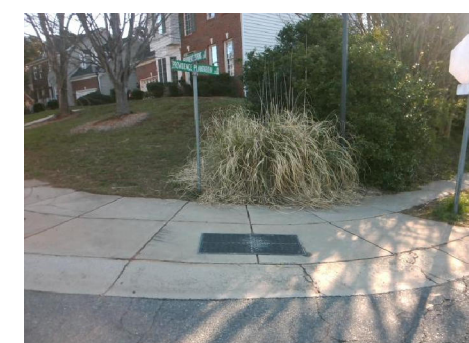
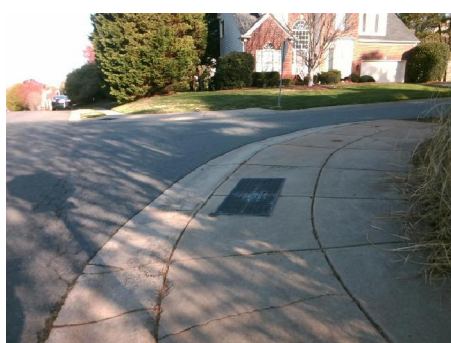
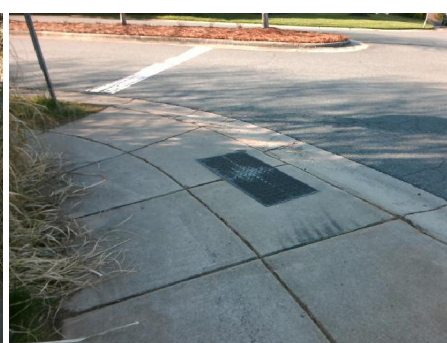
**Not Found, R304.5.3**

Compliance	Description	Data	Compliance	Description	Data
N/A	Ramp Length (in)	48.0	Yes	Ramp Slope (%)	5.1
Yes	Ramp Width (in)	48.0	No	Ramp XSlope (%)	8.1
N/A	Flare Type LT	N/A	N/A	Flare Type RT	N/A
N/A	Flare Slope LT (%)	N/A	N/A	Flare Slope RT (%)	N/A
N/A	Flare Traversable LT?	N/A	N/A	Flare Traversable RT?	N/A
N/A	Landing Length (in)	N/A	N/A	DWS Provided?	N/A
N/A	Landing Width (in)	N/A	N/A	DWS Contrast?	N/A
N/A	Landing Slope (%)	N/A	N/A	DWS Length (in)	N/A
N/A	Landing X Slope (%)	N/A	N/A	DWS Full Width?	N/A
N/A	Landing Curb? (Y/N)	N/A	N/A	DWS Offset (in)	N/A
N/A	Shared Landing?	N/A			
N/A	Gutter Ponding?	N/A	N/A	Gutter Slope (%)	N/A
N/A	Gutter Lip Ht (in)	N/A	N/A	Gutter X Slope (%)	N/A
N/A	Painted X Walk1?	No	N/A	Painted X Walk2?	N/A
	X Walk 1 Direction	To NW		X Walk 2 Direction	N/A
N/A	X Walk 1 Width (in)	N/A	N/A	X Walk 2 Width (in)	N/A
	X Walk 1 Slope (%)	3.6		X Walk 2 Slope (%)	N/A
	X Walk 1 X Slope (%)	4.0		X Walk 2 X Slope (%)	N/A

N/A	Ramp inside XWalk1?	N/A	N/A	Ramp inside XWalk2?	N/A
	Road Slope (%)	N/A	N/A	Clear Space?	N/A
	Road X Slope (%)	N/A	N/A	Clear Space to XWalk (in)	N/A
N/A	Any Obstructions?	N/A	N/A	Storm Grate/Utility Hazard?	N/A
	Obstruction Type			Storm Grate/Utility Type	
		N/A			N/A
			Yes	Surface Condition? (G/P)	Good

**Remove & Replace Entire Ramp.**
