# Access Compliance Report

## Public Rights-of-Way

### (Curb Ramps)

| Intersection ID: 8279 | Main Street: HONEYWOOD_AV | Cross Street: KENTUCKY_AV | Location: | E |

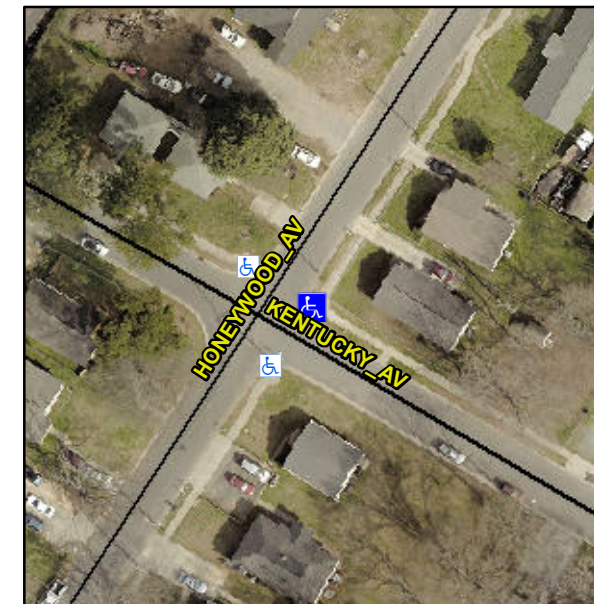
| ADA ID: FB20DE02EC59 | Ramp Type: PerpDiag | Initial Pass/Fail: Fail | Overall Compliance: No | Severity Score: 25 |

**Not Found, R304.5.3**

| Compliance | Description | Data | Compliance | Description | Data |
|---|---|---|---|---|---|
| Yes | Ramp Width (in) | 48.0 | No | Ramp XSlope (%) | 8.2 |

**Remove & Replace Curb Ramp With Two New Directional Ramps or Equivalent.**

Total Cost: \$ 3200.00
