Access Compliance Report Public Rights-of-Way (Curb Ramps)

Intersection ID: N/A Main Street: STRAWBERRY FIELDS LN Cross Street: MAGGIE MAY LN Location: S **ADA ID: FB2DF32D9474** Ramp Type: BlendTrans1 Initial Pass/Fail: Fail **Overall Compliance: No Severity Score:** 10

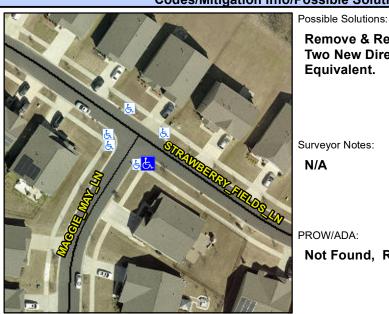
Not Found, R304.5.1, R304.5.3

Comp	oliance Description	Data	Comp	liance	Description	Data
N/A	Ramp Length (in)	96.0	Yes	Blend	Trans Slope (%)	3.3
No	Ramp Width (in)	45.0	No	Blend	Trans XSlope (%)	2.2
N/A	Flare Type LT	N/A	N/A	Flare	Type RT	N/A
N/A	Flare Slope LT (%)	N/A	N/A	Flare	Slope RT (%)	N/A
N/A	Flare Traversable LT?	N/A	N/A	Flare	Traversable RT?	N/A
N/A	Landing Length (in)	N/A	N/A	DWS	Provided?	N/A
N/A	Landing Width (in)	N/A	N/A	DWS	Contrast?	N/A
N/A	Landing Slope (%)	N/A	N/A	DWS	Length (in)	N/A
N/A	Landing X Slope (%)	N/A	N/A	DWS	Full Width?	N/A
N/A	Landing Curb? (Y/N)	N/A	N/A	DWS	Offset (in)	N/A
N/A	Shared Landing?	N/A				
N/A	Gutter Ponding?	N/A	N/A	Gutte	r Slope (%)	N/A
N/A	Gutter Lip Ht (in)	N/A	N/A	Gutte	r X Slope (%)	N/A
N/A	Painted X Walk1?	No	N/A	Paint	ed X Walk2?	N/A
	X Walk 1 Direction	To NE		X Wa	lk 2 Direction	N/A
	X Walk 1 Width (in)	N/A		X Wa	lk 2 Width (in)	N/A
	X Walk 1 Slope (%)	1.1		X Wa	lk 2 Slope (%)	N/A
	X Walk 1 X Slope (%)	1.0		X Wa	lk 2 X Slope (%)	N/A

N/A	Ramp inside XWalk1?	N/A	N/A	Ramp	inside XWalk2?	N/A
	Road Slope (%)	1.0		Clear	Space?	N/A
	Road X Slope (%)	1.1	N/A	Clear	Space to XWalk (in)	N/A
N/A	Any Obstructions?	N/A	N/A	Storm	Grate/Utility Hazard?	N/A
	Obstruction Type			Storm	Grate/Utility Type	
		N/A				N/A

Remove & Replace Curb Ramp With Two New Directional Ramps or Equivalent.
