Access Compliance Report

Public Rights-of-Way

(Curb Ramps)

Intersection ID: 51470		Main Street: HUCKS_LANDING_DR		Cross Street: HUCKS_RD		Location:		W									
ADA ID: FB2FB1340D0B		Ramp Type: Directional1		Initial Pass/Fail: Pass		Overall Compliance: No		Severity Score: 5									
Codes/Mitigation Info/Possible Solution				Field Measurements/Component Compliance													
<div>

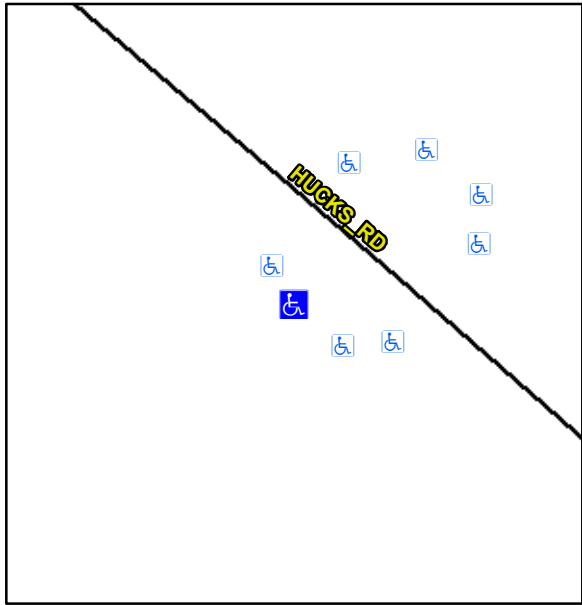
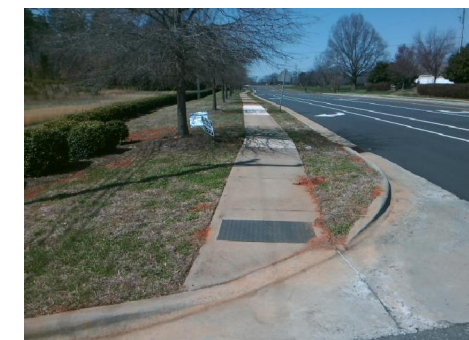
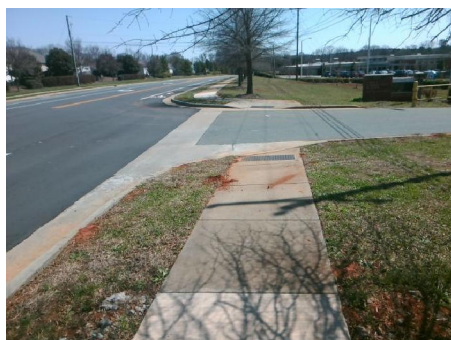
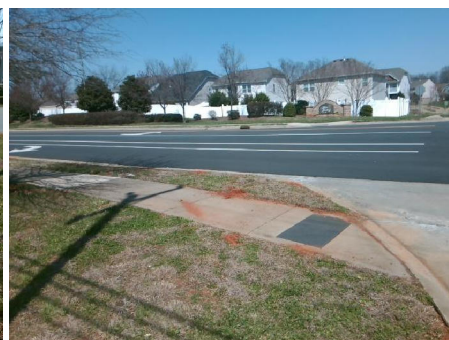
</div> <div>Street 1 NameHUCKS LANDING DR</div> <div>Stop Condition-Street 1None</div> <div>Street 2 NameN/A</div> <div>Stop Condition-Street 2N/A</div>				Possible Solutions:		Compliance		Description		Data		Compliance		Description		Data	
				Remove & Replace Entire Ramp. Remove & Replace Gutter.		N/A		Ramp Length (in)		158.0		No		Grade Break?		No	
						Yes		Ramp Width (in)		60.0		N/A		Grade Break Slope (%)		7.8	
						Yes		Ramp Slope (%)		6.1		N/A		Grade Break XSlope (%)		3.4	
						Yes		Ramp XSlope (%)		2.0							
						N/A		Flare Type LT		N/A		N/A		Flare Type RT		N/A	
						N/A		Flare Slope LT (%)		N/A		N/A		Flare Slope RT (%)		N/A

N/A		Flare Traversable LT?		N/A		N/A		Flare Traversable RT?		N/A	
						Yes		Landing Length (in)		60.5		Yes		DWS Provided?		Yes	
						Yes		Landing Width (in)		59.0		Yes		DWS Contrast?		Yes	
		No		Landing Slope (%)		5.5		Yes		DWS Length (in)		24.0					
		Yes		Landing X Slope (%)		3.0		Yes		DWS Full Width?		Yes					
		N/A		Landing Curb? (Y/N)		N/A		Yes		DWS Offset LT (in)		35.0					
		N/A		Shared Landing?		No		Yes		DWS Offset RT (in)		1.0					
		Yes		Gutter Ponding?		No		No		Gutter Slope (%)		6.8					
		Yes		Gutter Lip Ht (in)		0.0		Yes		Gutter X Slope (%)		3.9					
		N/A		Painted X Walk1?		No				Road Slope (%)		0.8					
				X Walk 1 Direction		To SE				Road X Slope (%)		3.9					
				X Walk 1 Width (in)		N/A				Clear Space?		Yes					
				X Walk 1 Slope (%)		0.8		N/A		Clear Space to XWalk (in)		N/A					
				X Walk 1 X Slope (%)		3.9		Yes		Storm Grate/Utility Hazard?		No					
		N/A		Ramp inside XWalk1?		N/A				Storm Grate/Utility Type

Yes		Any Obstructions?		No						N/A					
				Obstruction Type				Yes		Surface Condition? (G/P)		Good					
								N/A		No		Curb Slope (%)		12.6			
		Total Cost:		\$		2350.00
