# Access Compliance Report

## Public Rights-of-Way

### (Curb Ramps)

| Intersection ID: 7771 | Main Street: SENIOR_DR | Cross Street: TWINFIELD_DR | Location: | N |

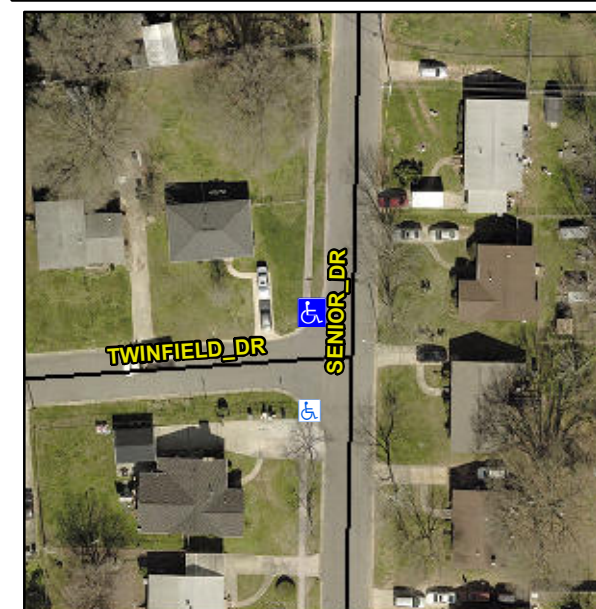
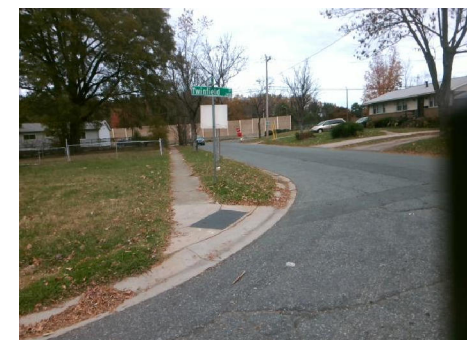
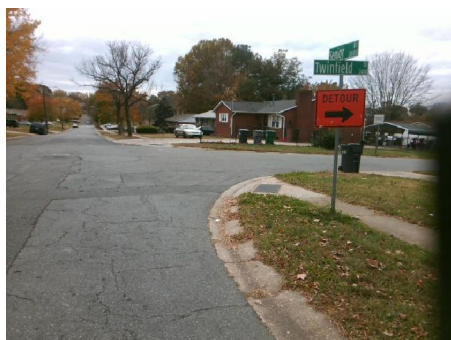
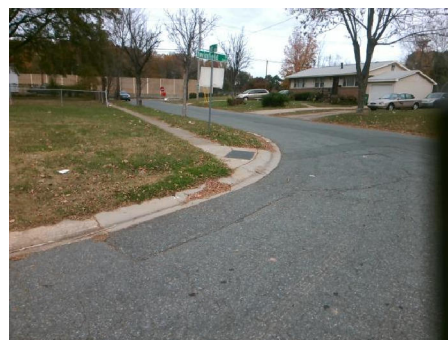
**Not Found, R304.5.3, R304.2.1, R304.2.2-Perp, R304.3.2-Para, R304.5.4**

| Compliance | Description | Data | Compliance | Description | Data |
|---|---|---|---|---|---|
| Yes | Ramp Width (in) | 48.0 | No | BlendTrans XSlope (%) | 3.7 |
| No | Landing Length (in) | 36.0 | Yes | DWS Provided? | Yes |
| No | Landing Width (in) | 25.0 | Yes | DWS Contrast? | Yes |
| No | Landing Slope (%) | 2.3 | Yes | DWS Length (in) | 24.0 |
| No | Landing X Slope (%) | 2.2 | Yes | DWS Full Width? | Yes |
| Yes | Gutter Ponding? | No | No | Gutter Slope (%) | 7.4 |
| Yes | Gutter Lip Ht (in) | 0.0 | No | Gutter X Slope (%) | 7.2 |
| | | | No | Curb Slope (%) | 33.0 |

**Remove & Replace Curb Ramp With Two New Directional Ramps or Equivalent. Remove & Replace Gutter.**
