# Access Compliance Report

## Public Rights-of-Way

### (Curb Ramps)

Intersection ID: 11870	Main Street: CAMP_GREENE_ST	Cross Street: GARIBALDI_AV	Location: SE
ADA ID: FB38AEA37DAB	Ramp Type: Perp	Initial Pass/Fail: Fail	Overall Compliance: No
Codes/Mitigation Info/Possible Solution			Severity Score: 10
			Field Measurements/Component Compliance

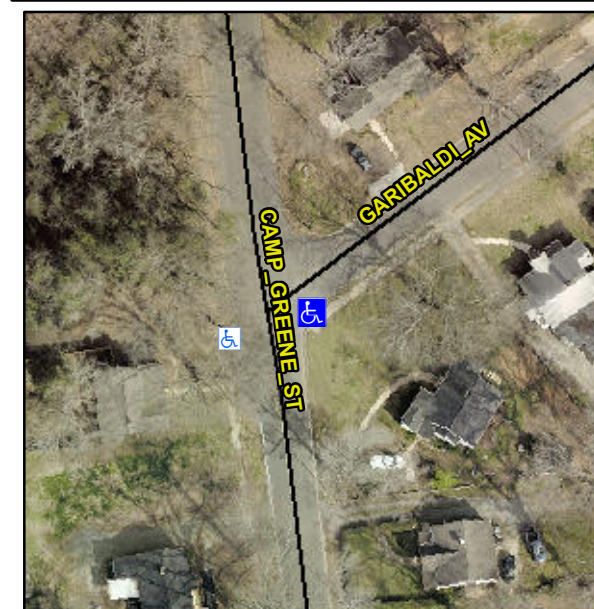
**Not Found, R304.5.1, R304.5.3**

Compliance	Description	Data	Compliance	Description	Data
N/A	Ramp Length (in)	25.0	Yes	Ramp Slope (%)	7.3
No	Ramp Width (in)	47.0	No	Ramp XSlope (%)	3.8
N/A	Flare Type LT	N/A	N/A	Flare Type RT	N/A
N/A	Flare Slope LT (%)	N/A	N/A	Flare Slope RT (%)	N/A
N/A	Flare Traversable LT?	N/A	N/A	Flare Traversable RT?	N/A
N/A	Landing Length (in)	N/A	N/A	DWS Provided?	N/A
N/A	Landing Width (in)	N/A	N/A	DWS Contrast?	N/A
N/A	Landing Slope (%)	N/A	N/A	DWS Length (in)	N/A
N/A	Landing X Slope (%)	N/A	N/A	DWS Full Width?	N/A
N/A	Landing Curb? (Y/N)	N/A	N/A	DWS Offset (in)	N/A
N/A	Shared Landing?	N/A			
N/A	Gutter Ponding?	N/A	N/A	Gutter Slope (%)	N/A
N/A	Gutter Lip Ht (in)	N/A	N/A	Gutter X Slope (%)	N/A
N/A	Painted X Walk1?	No	N/A	Painted X Walk2?	N/A
	X Walk 1 Direction	To W		X Walk 2 Direction	N/A
N/A	X Walk 1 Width (in)	N/A	N/A	X Walk 2 Width (in)	N/A
	X Walk 1 Slope (%)	6.8		X Walk 2 Slope (%)	N/A
	X Walk 1 X Slope (%)	1.5		X Walk 2 X Slope (%)	N/A

N/A	Ramp inside XWalk1?	N/A	N/A	Ramp inside XWalk2?	N/A
	Road Slope (%)	N/A	N/A	Clear Space?	N/A
	Road X Slope (%)	N/A	N/A	Clear Space to XWalk (in)	N/A
N/A	Any Obstructions?	N/A	N/A	Storm Grate/Utility Hazard?	N/A
	Obstruction Type			Storm Grate/Utility Type	
		N/A			N/A
			Yes	Surface Condition? (G/P)	Good

Possible Solutions:

**Remove & Replace Entire Ramp.**
