# Access Compliance Report

## Public Rights-of-Way

### (Curb Ramps)

Intersection ID: 25199	Main Street: DONNEGAL_FARM_RD	Cross Street: BRIDLE_BROOK_WY	Location: SE
ADA ID: FB3C91A8E996	Ramp Type: PerpDiag	Initial Pass/Fail: Fail	Overall Compliance: No
		Severity Score: 12.5

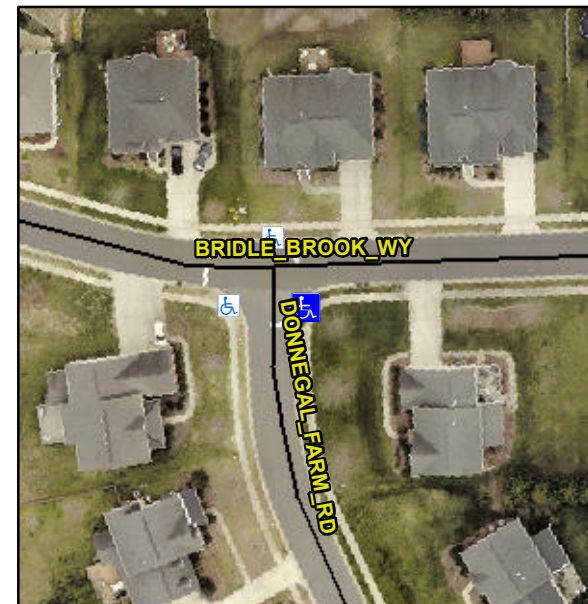
**Not Found, R304.2.2**

Compliance	Description	Data	Compliance	Description	Data
N/A	Ramp Length (in)	47.0	No	Ramp Slope (%)	9.2
Yes	Ramp Width (in)	48.0	Yes	Ramp XSlope (%)	0.5
N/A	Flare Type LT	N/A	N/A	Flare Type RT	N/A
N/A	Flare Slope LT (%)	N/A	N/A	Flare Slope RT (%)	N/A
N/A	Flare Traversable LT?	N/A	N/A	Flare Traversable RT?	N/A
N/A	Landing Length (in)	N/A	N/A	DWS Provided?	N/A
N/A	Landing Width (in)	N/A	N/A	DWS Contrast?	N/A
N/A	Landing Slope (%)	N/A	N/A	DWS Length (in)	N/A
N/A	Landing X Slope (%)	N/A	N/A	DWS Full Width?	N/A
N/A	Landing Curb? (Y/N)	N/A	N/A	DWS Offset (in)	N/A
N/A	Shared Landing?	N/A			
N/A	Gutter Ponding?	N/A	N/A	Gutter Slope (%)	N/A
N/A	Gutter Lip Ht (in)	N/A	N/A	Gutter X Slope (%)	N/A
N/A	Painted X Walk1?	No	N/A	Painted X Walk2?	No
	X Walk 1 Direction	To N		X Walk 2 Direction	To W
N/A	X Walk 1 Width (in)	N/A	N/A	X Walk 2 Width (in)	N/A
	X Walk 1 Slope (%)	0.4		X Walk 2 Slope (%)	3.4
	X Walk 1 X Slope (%)	4.4		X Walk 2 X Slope (%)	0.9

N/A	Ramp inside XWalk1?	N/A	N/A	Ramp inside XWalk2?	N/A
	Road Slope (%)	0.5	N/A	Clear Space?	N/A
	Road X Slope (%)	4.0	N/A	Clear Space to XWalk (in)	N/A
N/A	Any Obstructions?	N/A	N/A	Storm Grate/Utility Hazard?	N/A
	Obstruction Type			Storm Grate/Utility Type	
		N/A			N/A
			Yes	Surface Condition? (G/P)	Good

**Remove & Replace Curb Ramp With Two New Directional Ramps or Equivalent.**
