# Access Compliance Report

## Public Rights-of-Way

### (Curb Ramps)

Intersection ID: 10608	Main Street: N_DAVIDSON_ST	Cross Street: JORDAN_PL	Location: SW
ADA ID: FB3DE44CB28F	Ramp Type: Perp	Initial Pass/Fail: Fail	Overall Compliance: No
		Severity Score: 8.75

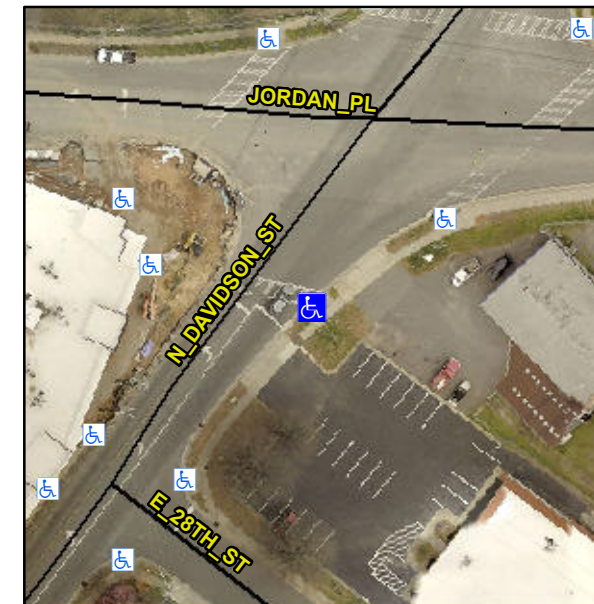
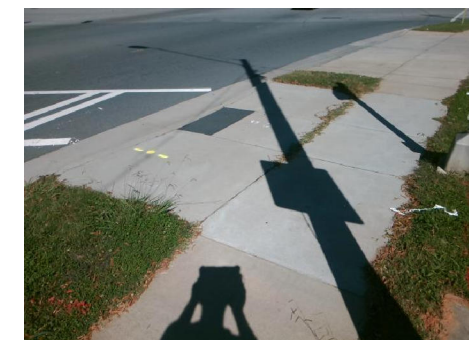
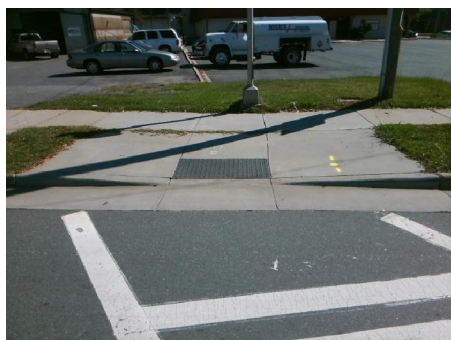
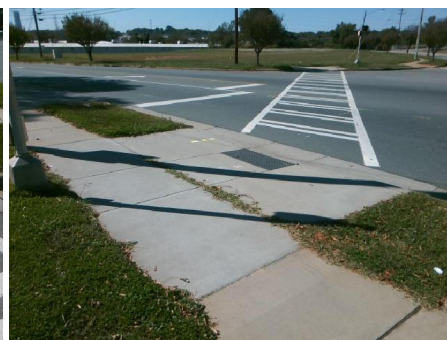
**Not Found, R304.5.1**

Compliance	Description	Data	Compliance	Description	Data
N/A	Ramp Length (in)	72.0	Yes	Ramp Slope (%)	5.8
No	Ramp Width (in)	47.5	Yes	Ramp XSlope (%)	1.3
N/A	Flare Type LT	N/A	N/A	Flare Type RT	N/A
N/A	Flare Slope LT (%)	N/A	N/A	Flare Slope RT (%)	N/A
N/A	Flare Traversable LT?	N/A	N/A	Flare Traversable RT?	N/A
N/A	Landing Length (in)	N/A	N/A	DWS Provided?	N/A
N/A	Landing Width (in)	N/A	N/A	DWS Contrast?	N/A
N/A	Landing Slope (%)	N/A	N/A	DWS Length (in)	N/A
N/A	Landing X Slope (%)	N/A	N/A	DWS Full Width?	N/A
N/A	Landing Curb? (Y/N)	N/A	N/A	DWS Offset (in)	N/A
N/A	Shared Landing?	N/A			
N/A	Gutter Ponding?	N/A	N/A	Gutter Slope (%)	N/A
N/A	Gutter Lip Ht (in)	N/A	N/A	Gutter X Slope (%)	N/A
N/A	Painted X Walk1?	Yes	N/A	Painted X Walk2?	N/A
	X Walk 1 Direction	To NW		X Walk 2 Direction	N/A
N/A	X Walk 1 Width (in)	98.0	N/A	X Walk 2 Width (in)	N/A
	X Walk 1 Slope (%)	0.9		X Walk 2 Slope (%)	N/A
	X Walk 1 X Slope (%)	1.8		X Walk 2 X Slope (%)	N/A

N/A	Ramp inside XWalk1?	Yes	N/A	Ramp inside XWalk2?	N/A
	Road Slope (%)	N/A	N/A	Clear Space?	N/A
	Road X Slope (%)	N/A	N/A	Clear Space to XWalk (in)	N/A
N/A	Any Obstructions?	N/A	N/A	Storm Grate/Utility Hazard?	N/A
	Obstruction Type			Storm Grate/Utility Type	
		N/A			N/A
			Yes	Surface Condition? (G/P)	Good

**Remove & Replace Entire Ramp.**

Total Cost: \$ 1850.00
