# Access Compliance Report

## Public Rights-of-Way

### (Curb Ramps)

Intersection ID: 44938	Main Street: NATHAN_DR	Cross Street: ACORN_FOREST_LN	Location: SW
ADA ID: FB40A45F5D12	Ramp Type: PerpDiag	Initial Pass/Fail: Fail	Overall Compliance: No
Severity Score: 22.5			
Codes/Mitigation Info/Possible Solution		Field Measurements/Component Compliance

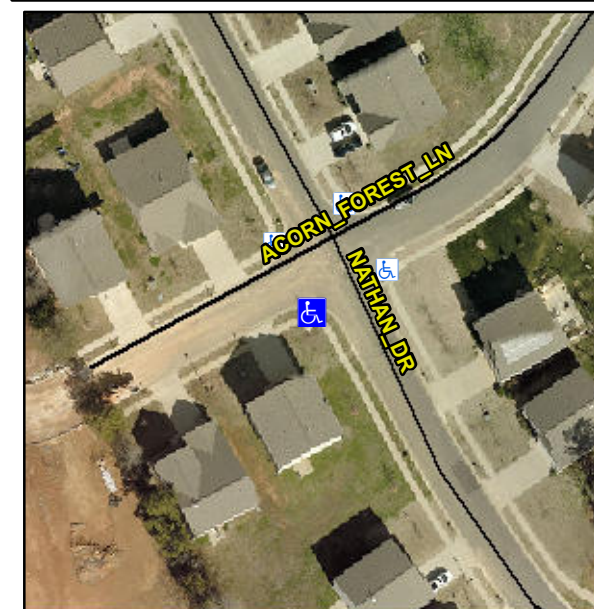
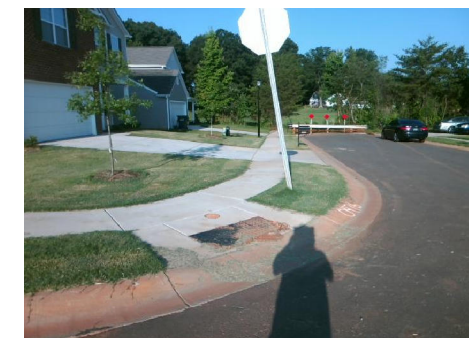
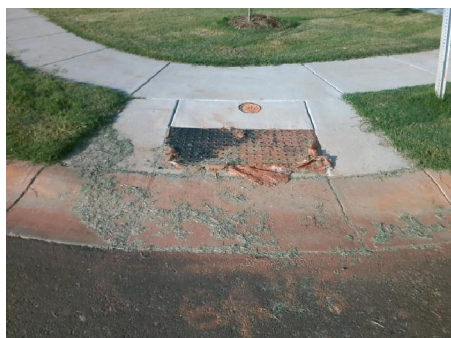
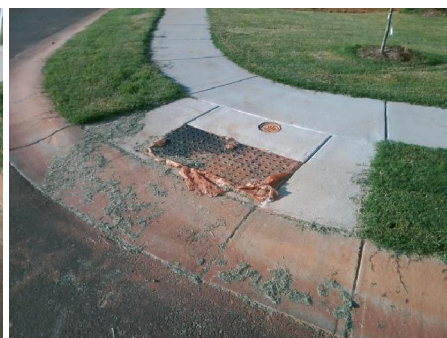
Compliance	Description	Data	Compliance	Description	Data
N/A	Ramp Length (in)	49.0	No	Ramp Slope (%)	11.1
No	Ramp Width (in)	46.0	No	Ramp XSlope (%)	3.1
N/A	Flare Type LT	N/A	N/A	Flare Type RT	N/A
N/A	Flare Slope LT (%)	N/A	N/A	Flare Slope RT (%)	N/A
N/A	Flare Traversable LT?	N/A	N/A	Flare Traversable RT?	N/A
N/A	Landing Length (in)	N/A	N/A	DWS Provided?	N/A
N/A	Landing Width (in)	N/A	N/A	DWS Contrast?	N/A
N/A	Landing Slope (%)	N/A	N/A	DWS Length (in)	N/A
N/A	Landing X Slope (%)	N/A	N/A	DWS Full Width?	N/A
N/A	Landing Curb? (Y/N)	N/A	N/A	DWS Offset (in)	N/A
N/A	Shared Landing?	N/A			
N/A	Gutter Ponding?	N/A	N/A	Gutter Slope (%)	N/A
N/A	Gutter Lip Ht (in)	N/A	N/A	Gutter X Slope (%)	N/A
N/A	Painted X Walk1?	No	N/A	Painted X Walk2?	No
	X Walk 1 Direction	To E		X Walk 2 Direction	To N
N/A	X Walk 1 Width (in)	N/A	N/A	X Walk 2 Width (in)	N/A
	X Walk 1 Slope (%)	2.4		X Walk 2 Slope (%)	0.7
	X Walk 1 X Slope (%)	1.5		X Walk 2 X Slope (%)	2.9

N/A	Ramp inside XWalk1?	N/A	N/A	Ramp inside XWalk2?	N/A
	Road Slope (%)	3.5	N/A	Clear Space?	N/A
	Road X Slope (%)	1.1	N/A	Clear Space to XWalk (in)	N/A
N/A	Any Obstructions?	N/A	N/A	Storm Grate/Utility Hazard?	N/A
	Obstruction Type			Storm Grate/Utility Type	
		N/A			N/A
			Yes	Surface Condition? (G/P)	Good

**Remove & Replace Curb Ramp With Two New Directional Ramps or Equivalent.**

**R304.5.1, R304.2.2, R304.5.3**
