Access Compliance Report Public Rights-of-Way (Curb Ramps)

Intersection ID: 7381 Main Street: MAPLEGROVE_DR Cross Street: N_HOSKINS_RD Location: NW

ADA ID: FB42BC28E3EE Ramp Type: Perp Initial Pass/Fail: Fail Overall Compliance: No Severity Score: 46.25

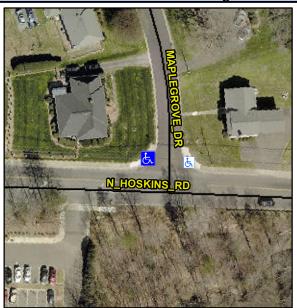
Field Measurements/Component Compliance								
Comp	liance Description	Data	Comp	liance Description	Data			
N/A	Ramp Length (in)	59.5	No	Ramp Slope (%)	8.7			
No	Ramp Width (in)	37.0	No	Ramp XSlope (%)	8.7			
N/A	Flare Type LT	N/A	N/A	Flare Type RT	N/A			
N/A	Flare Slope LT (%)	N/A	N/A	Flare Slope RT (%)	N/A			
N/A	Flare Traversable LT?	N/A	N/A	Flare Traversable RT?	N/A			
N/A	Landing Length (in)	N/A	N/A	DWS Provided?	N/A			
N/A	Landing Width (in)	N/A	N/A	DWS Contrast?	N/A			
N/A	Landing Slope (%)	N/A	N/A	DWS Length (in)	N/A			
N/A	Landing X Slope (%)	N/A	N/A	DWS Full Width?	N/A			
N/A	Landing Curb? (Y/N)	N/A	N/A	DWS Offset (in)	N/A			
N/A	Shared Landing?	N/A						
N/A	Gutter Ponding?	N/A	N/A	Gutter Slope (%)	N/A			
N/A	Gutter Lip Ht (in)	N/A	N/A	Gutter X Slope (%)	N/A			
N/A	Painted X Walk1?	No	N/A	Painted X Walk2?	N/A			
	X Walk 1 Direction	To SE		X Walk 2 Direction	N/A			
N/A	X Walk 1 Width (in)	N/A	N/A	X Walk 2 Width (in)	N/A

X Walk 1 Slope (%)	6.3		X Walk 2 Slope (%)	N/A			
	X Walk 1 X Slope (%)	6.7		X Walk 2 X Slope (%)	N/A			
N/A	Ramp inside XWalk1?	N/A	N/A	Ramp inside XWalk2?	N/A			
	Road Slope (%)	N/A	N/A	Clear Space?	N/A			
	Road X Slope (%)	N/A	N/A	Clear Space to XWalk (in)	N/A			
N/A	Any Obstructions?	N/A	N/A	Storm Grate/Utility Hazard?	N/A			
	Obstruction Type			Storm Grate/Utility Type				
		N/A			N/A			
			Yes	Surface Condition? (G/P)	Good

Possible Solutions:	Co
Remove & Replace Entire Ramp.	
	No
	N/A
	N/A
	N/
	N/A
Surveyor Notes:	N/A
N/A	N/A
	N/A
	N/A
	N/A
PROW/ADA:	N/A
Not Found, R304.5.1, R304.2.2,	N/A
R304.5.3	N/
	N/A
	N/

1850.00
