Access Compliance Report

Public Rights-of-Way

(Curb Ramps)

Intersection ID: 12633	Main Street: BERRYHILL_RD	Cross Street: WILKINSON_BV	Location: NW
ADA ID: FB4C513750D5	Ramp Type: BlendTrans1	Initial Pass/Fail: Fail	Overall Compliance: No
		Severity Score: 1.25

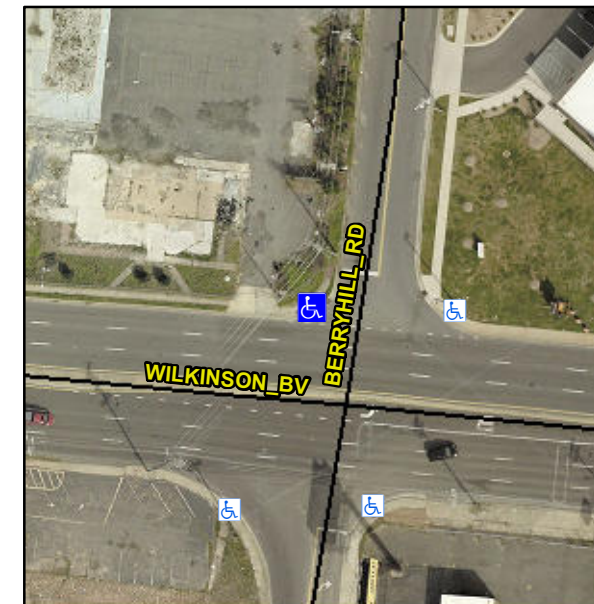
RT RP < 5%

Not Found, R304.5.3

Compliance	Description	Data	Compliance	Description	Data
N/A	Ramp Length (in)	84.0	Yes	BlendTrans Slope (%)	4.9
Yes	Ramp Width (in)	48.0	No	BlendTrans XSlope (%)	4.0
N/A	Flare Type LT	N/A	N/A	Flare Type RT	N/A
N/A	Flare Slope LT (%)	N/A	N/A	Flare Slope RT (%)	N/A
N/A	Flare Traversable LT?	N/A	N/A	Flare Traversable RT?	N/A
N/A	Landing Length (in)	N/A	N/A	DWS Provided?	N/A
N/A	Landing Width (in)	N/A	N/A	DWS Contrast?	N/A
N/A	Landing Slope (%)	N/A	N/A	DWS Length (in)	N/A
N/A	Landing X Slope (%)	N/A	N/A	DWS Full Width?	N/A
N/A	Landing Curb? (Y/N)	N/A	N/A	DWS Offset (in)	N/A
N/A	Shared Landing?	N/A			
N/A	Gutter Ponding?	N/A	N/A	Gutter Slope (%)	N/A
N/A	Gutter Lip Ht (in)	N/A	N/A	Gutter X Slope (%)	N/A
N/A	Painted X Walk1?	No	N/A	Painted X Walk2?	N/A
	X Walk 1 Direction	To E		X Walk 2 Direction	N/A
	X Walk 1 Width (in)	N/A		X Walk 2 Width (in)	N/A
	X Walk 1 Slope (%)	3.9		X Walk 2 Slope (%)	N/A
	X Walk 1 X Slope (%)	0.8		X Walk 2 X Slope (%)	N/A

N/A	Ramp inside XWalk1?	N/A	N/A	Ramp inside XWalk2?	N/A
	Road Slope (%)	0.8		Clear Space?	N/A
	Road X Slope (%)	3.9	N/A	Clear Space to XWalk (in)	N/A
N/A	Any Obstructions?	N/A	N/A	Storm Grate/Utility Hazard?	N/A
	Obstruction Type			Storm Grate/Utility Type	
		N/A			N/A
			Yes	Surface Condition? (G/P)	Good
			No	Curb Slope (%)	14.5

Remove & Replace Curb Ramp With Two New Directional Ramps or Equivalent.
