Access Compliance Report

Public Rights-of-Way

(Curb Ramps)

Intersection ID: 43865	Main Street: SIDNEY_CREST_AV	Cross Street: STONE_TRAIL_RD	Location: W
ADA ID: FB508F1FC751	Ramp Type: Perp	Initial Pass/Fail: Fail	Overall Compliance: No
Severity Score: 21.25			
Codes/Mitigation Info/Possible Solution		Field Measurements/Component Compliance

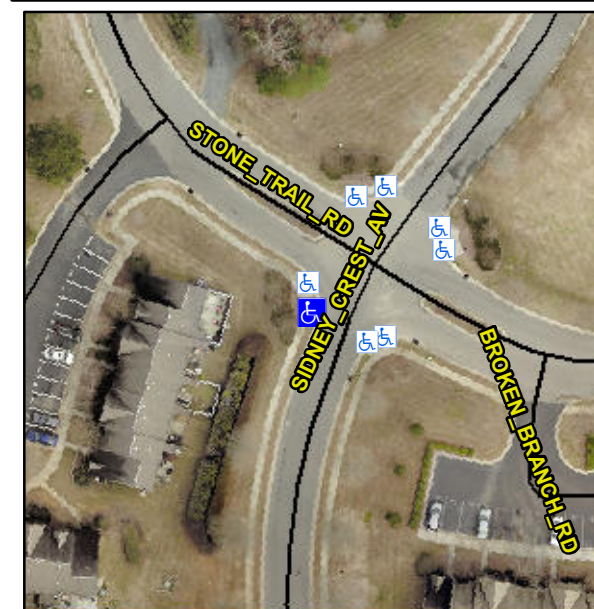
Not Found, R304.5.1, R304.5.3

Compliance	Description	Data	Compliance	Description	Data
N/A	Ramp Length (in)	47.0	Yes	Ramp Slope (%)	5.9
No	Ramp Width (in)	38.5	No	Ramp XSlope (%)	5.1
N/A	Flare Type LT	N/A	N/A	Flare Type RT	N/A
N/A	Flare Slope LT (%)	N/A	N/A	Flare Slope RT (%)	N/A
N/A	Flare Traversable LT?	N/A	N/A	Flare Traversable RT?	N/A
N/A	Landing Length (in)	N/A	N/A	DWS Provided?	N/A
N/A	Landing Width (in)	N/A	N/A	DWS Contrast?	N/A
N/A	Landing Slope (%)	N/A	N/A	DWS Length (in)	N/A
N/A	Landing X Slope (%)	N/A	N/A	DWS Full Width?	N/A
N/A	Landing Curb? (Y/N)	N/A	N/A	DWS Offset (in)	N/A
N/A	Shared Landing?	N/A			
N/A	Gutter Ponding?	N/A	N/A	Gutter Slope (%)	N/A
N/A	Gutter Lip Ht (in)	N/A	N/A	Gutter X Slope (%)	N/A
N/A	Painted X Walk1?	No	N/A	Painted X Walk2?	N/A
	X Walk 1 Direction	To SE		X Walk 2 Direction	N/A
N/A	X Walk 1 Width (in)	N/A	N/A	X Walk 2 Width (in)	N/A
	X Walk 1 Slope (%)	2.6		X Walk 2 Slope (%)	N/A
	X Walk 1 X Slope (%)	3.4		X Walk 2 X Slope (%)	N/A

Remove & Replace Entire Ramp.
